# 2024 Pavement Evaluation Report

## Tucker, GA

### October, 2024

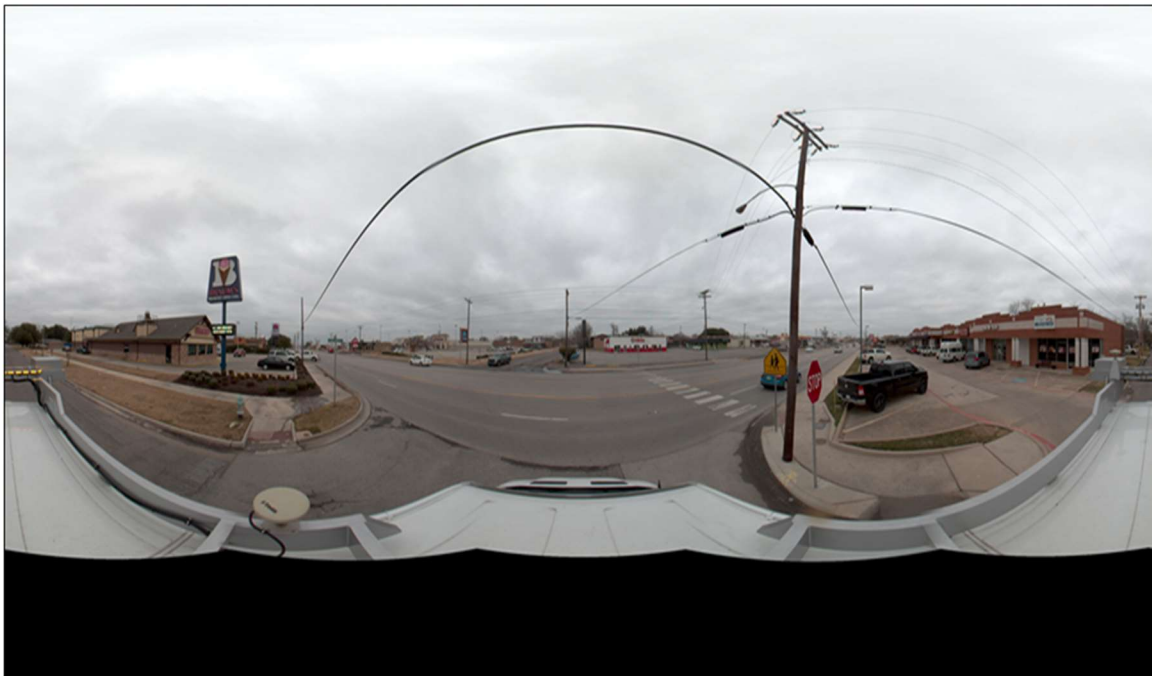
ROW images were also collected as part of this project. The RAC vehicle is configured with a Point Gray Ladybug 5+ 32MP 360-degree camera to provide a full panoramic image of the ROW, displayed in Figure 3.2. The images were captured at roughly 20-foot intervals and were post-processed using collected inertial and GPS data. This allowed for more accurate asset extraction to be completed.

*Figure 3.2: Right-of-Way Image Example*

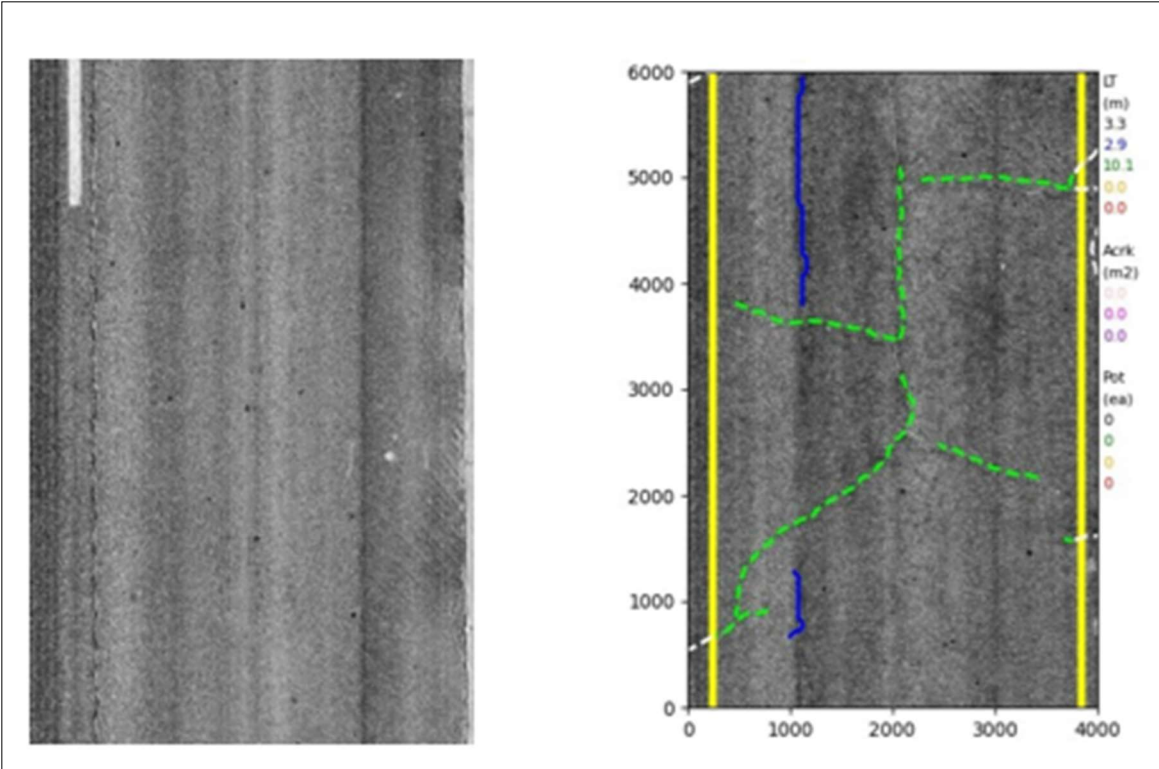
Road TRIP™ uses the depth map created by the Laser Crack Measurement System (LCMS) to locate the valleys and fissures within the surface of the roadway. These valleys and fissures are then measured and rated. Figures 4.2 and 4.3 display an example of distress overlay images.

Figure 4.2: LCMS Post PCI Processing Image

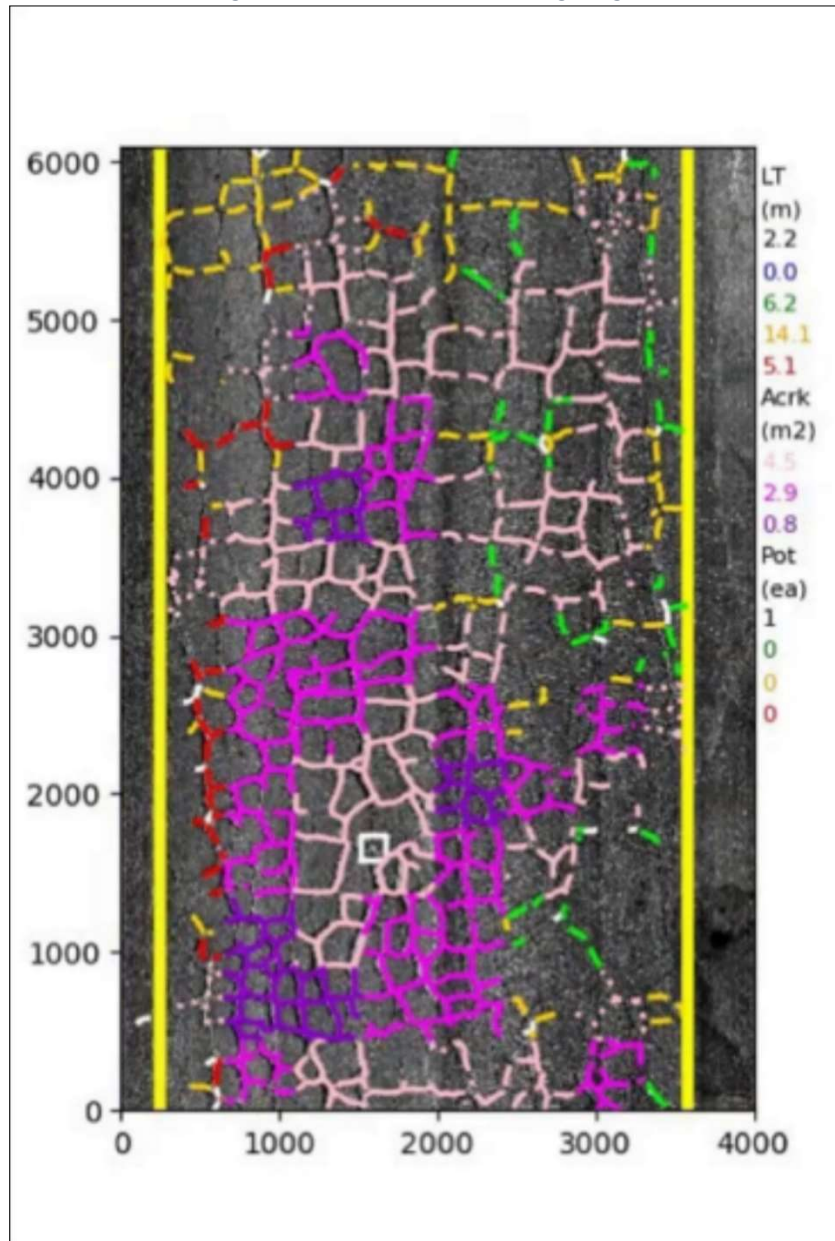
Figure 4.3: Example of Distress Overlay Images

The yellow line indicates the boundary of rated sample, green, yellow, and red lines indicate longitudinal and transverse cracking of low, moderate, and high extent, the pink, magenta, and violet lines indicate areas of low, moderate, and high severity cracking that has been filtered because it does not meet minimum length or width requirements. The overlay images provide a visual means by which to review the sensor.

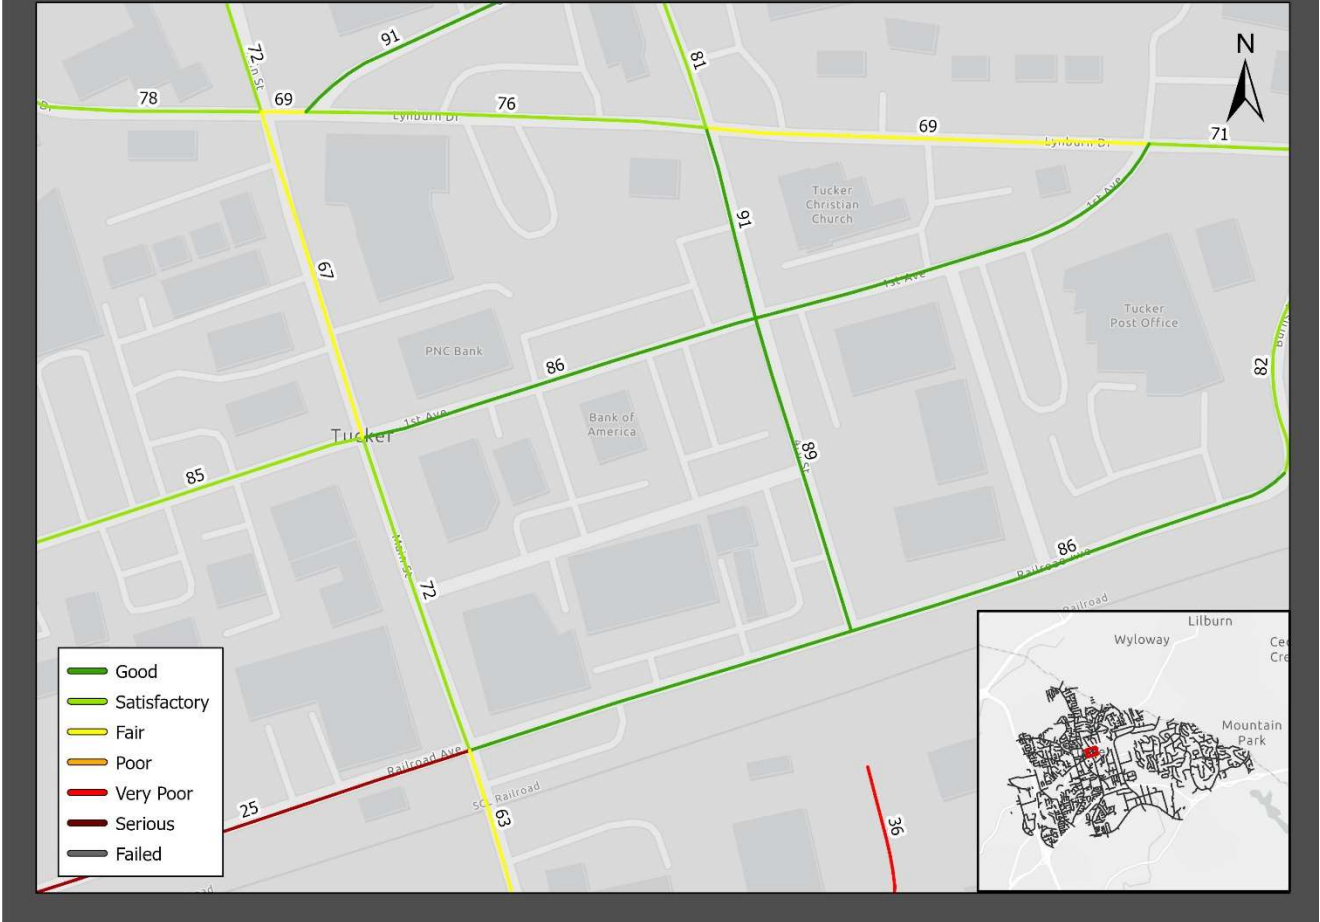
Figure 5.2 displays the Pavement Condition Rating distribution throughout the City's survey area roads. Figure 5.3 displays an example zoomed-in PCR map with the actual PCR values for each roadway section.

Figure 5.3: Tucker, GA PCR Example Map

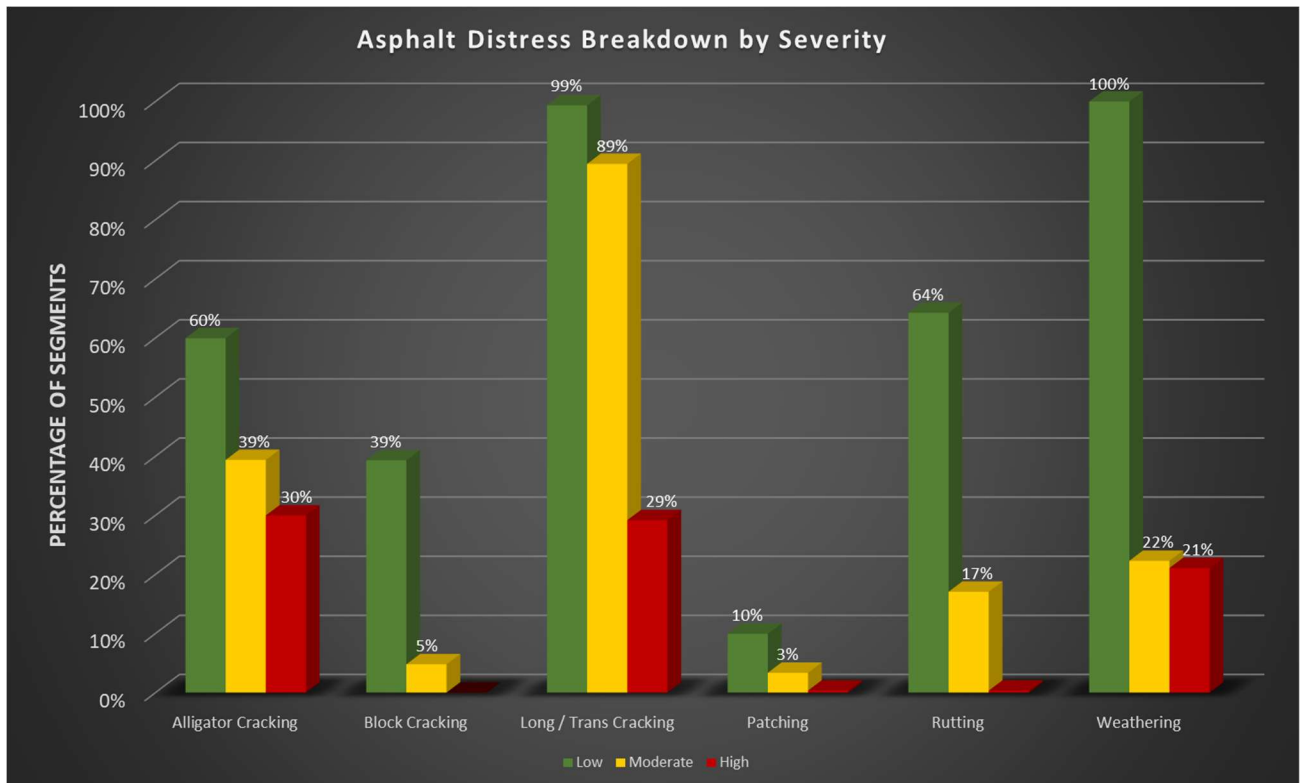
Figures 5.10, and Tables 5.5, 5.6 display the types of distresses found in the City’s asphalt and concrete roads. The figures and tables captioned “...Breakdown by Percentage of Segments” show the percentage of segments that contain a given distress and severity. Each distress is mutually exclusive, and the percentage doesn’t represent coverage in a segment, yet only the existence of the distress in a segment. For example, 60% low alligator cracking means that 60% of the total asphalt segments in the network have some low alligator cracking. Similarly, 30% high alligator cracking means that 30% of the total asphalt segments have some high alligator cracking.

Tables and figures captioned “...Breakdown by Average Density” show the average density of a given distress and severity. For example, 1.85% low alligator cracking in Table 5.6 means that the average density of all segments with some low alligator cracking is only 1.85%. Table 5.5 shows that 60% of asphalt streets contain low severity alligator cracking, but Table 5.6 shows that the average density of low alligator cracking is 1.85% thus, this distress, on average, does not cover a large area of the network as a whole. It is also important to note that not all distresses carry equal weight when calculating PCR. For example, one pothole can have more of an impact on the PCR score than 100% low weathering, so the following tables and figures should only be used to gain an understanding of the distresses present in the network.

Figure 5.10: Tucker, GA Asphalt Distress Breakdown

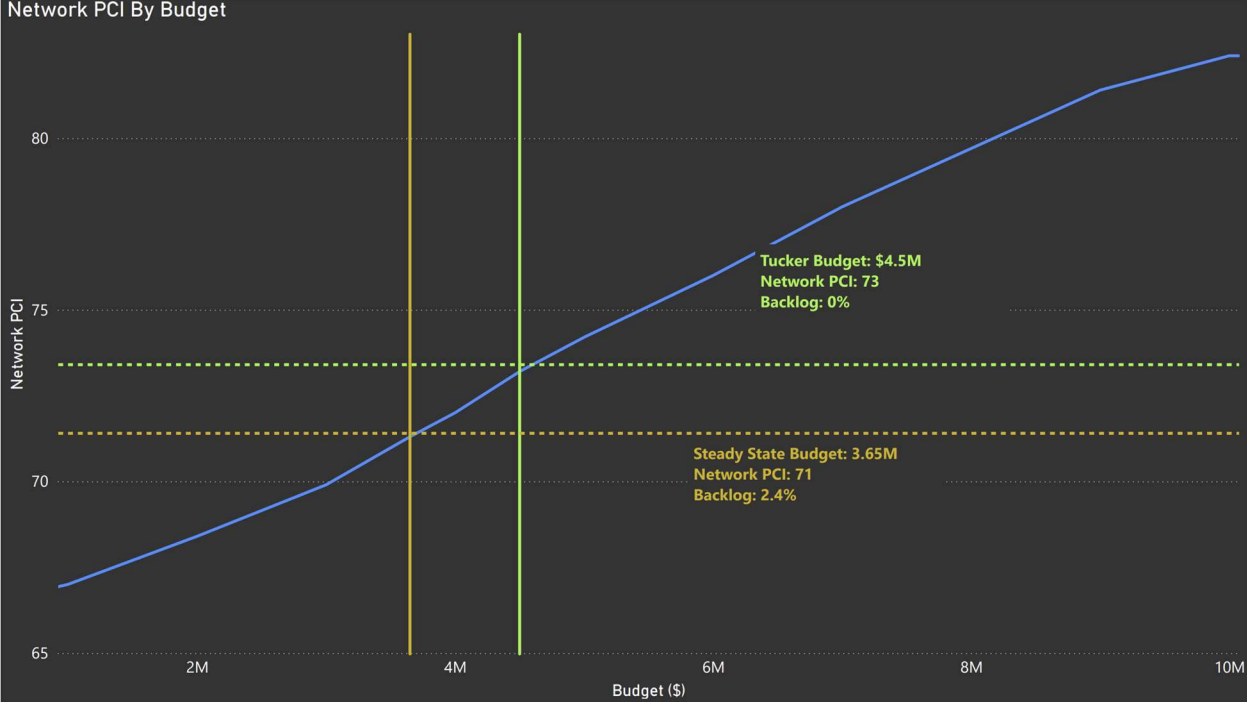
The network PCI in 2024 was 71. With the City’s current budget of \$4.5M annually, the network’s condition will increase to a PCI of 73. Figure 7.3 can be used to answer and predict the network PCI at any funding level between \$0 per year and \$9,000,000 per year. Figure 7.3 was used to predict the PCI at the following budgets in Table 7.4.

Figure 7.3: City of Tucker, GA- Predicted 5-Year Pavement Condition Index Outlook

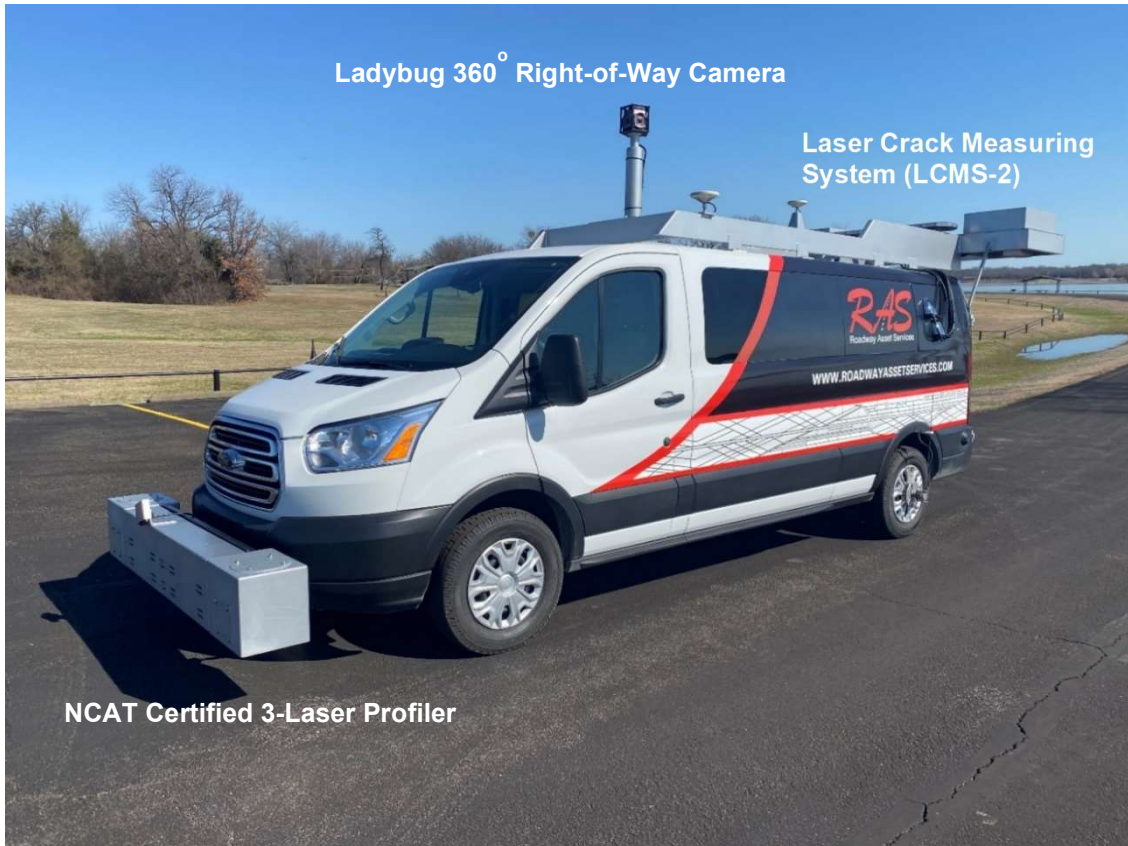
- An inertial profiler with line lasers (Used to capture Ride Comfort Index (RCI) measurements).

Figure 10.1: RAS RAC Vehicle

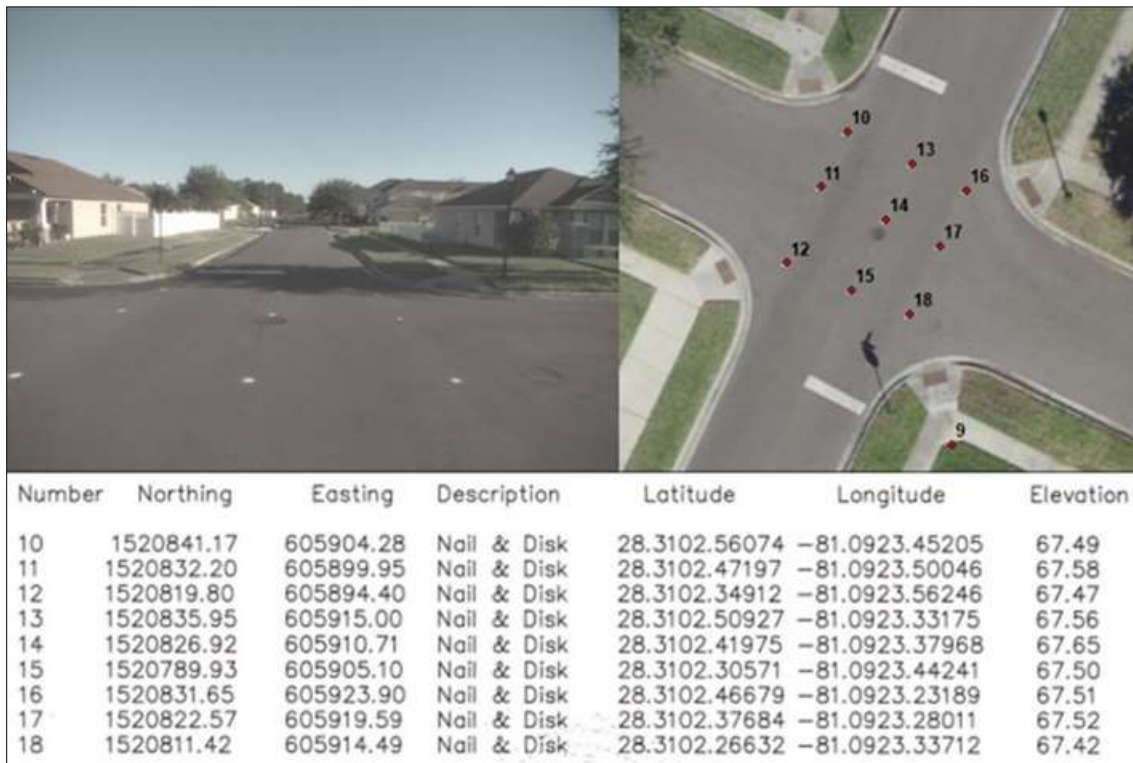
RAS RAC image collection includes a daily check of the on-board systems. This vehicle component check includes a calibration site survey of a nine-point grid in state plane coordinates (Figure 7.2). Each morning and afternoon, before and after a day's image collection, the RAC vehicle drives over the surveyed location. The RAC technician then extracts each point's location to verify the location of the point extracted was within approximately three feet of the surveyed points. RAS' QA/QC manual includes further details regarding RAC quality control procedures.

Figure 10.2: 9-Point Calibration Site Example
