ADDENDUM

Test Pit Exploration
Tucker Town Green
Railroad Avenue & 2nd Street
Tucker, DeKalb County, Georgia

Project No.: TUCKE-24-GA-07852-02

RE: Addendum Report of Test Pit Exploration
Tucker Town Green
Railroad Avenue & 2nd Stret
Tucker, DeKalb County, Georgia
Project No.: TUCKE-24-GA-07852-02

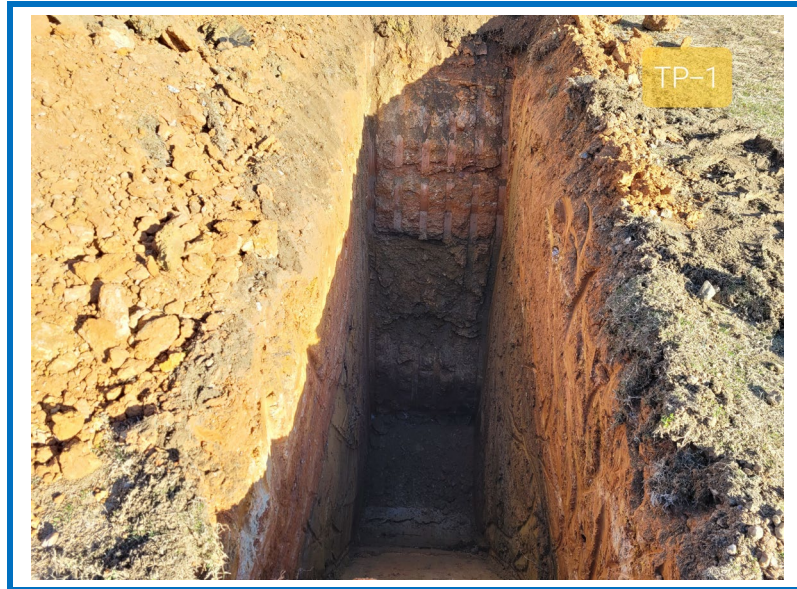
Photo 1: Test Pit TP-1

Depth (ft)	Elevation (ft)	Graphic Log	Visual Classification and Remarks	
			Topsoil - some gravel	0.2
			Sand - clayey, trace rock fragments, reddish brown with tan (fill)	
	1090			
5			Organic odor, trace lumber, trace roots, dry to moist, grayish brown to light gray	
	1085			9.0
			Sand - silty, some clay, trace rock fragments, moist, orangish tan and gray (alluvium)	
10				
	1080			14.0

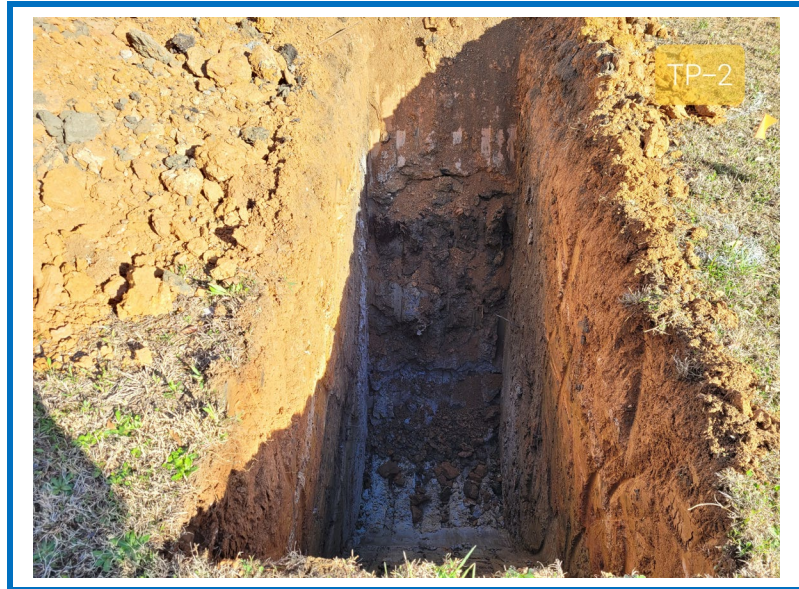
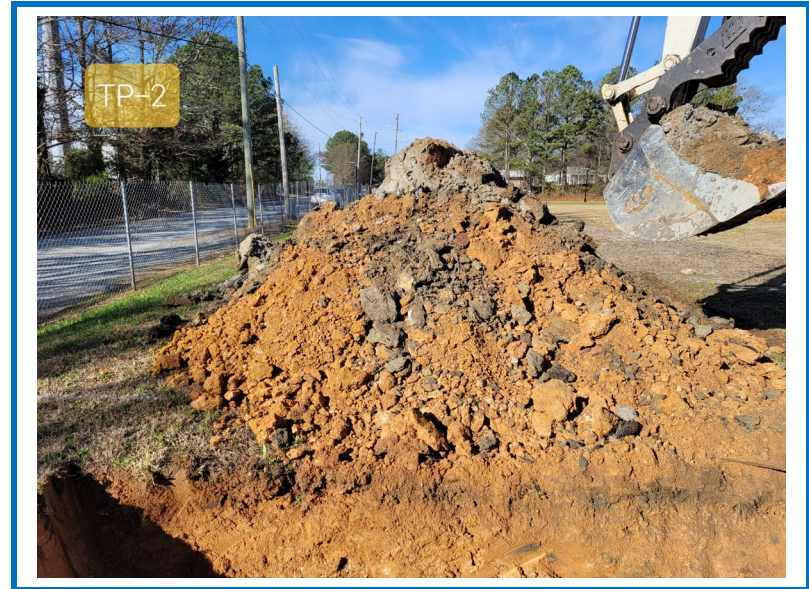
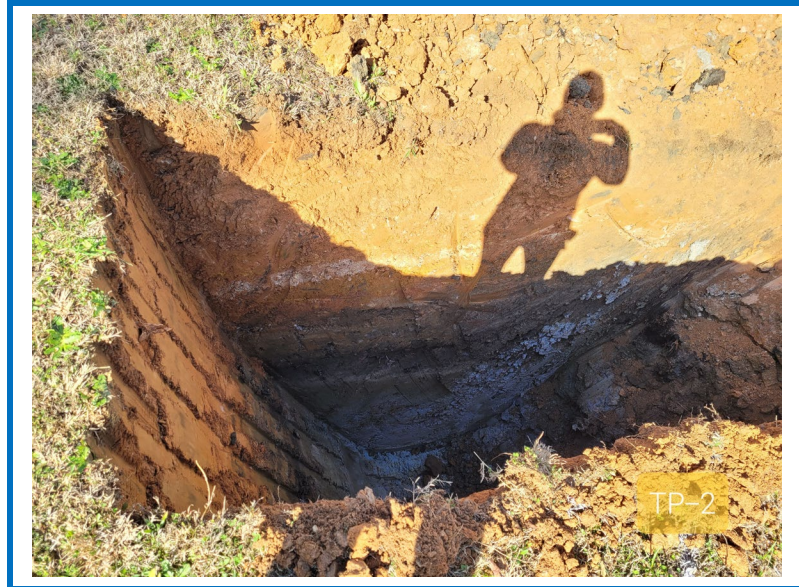
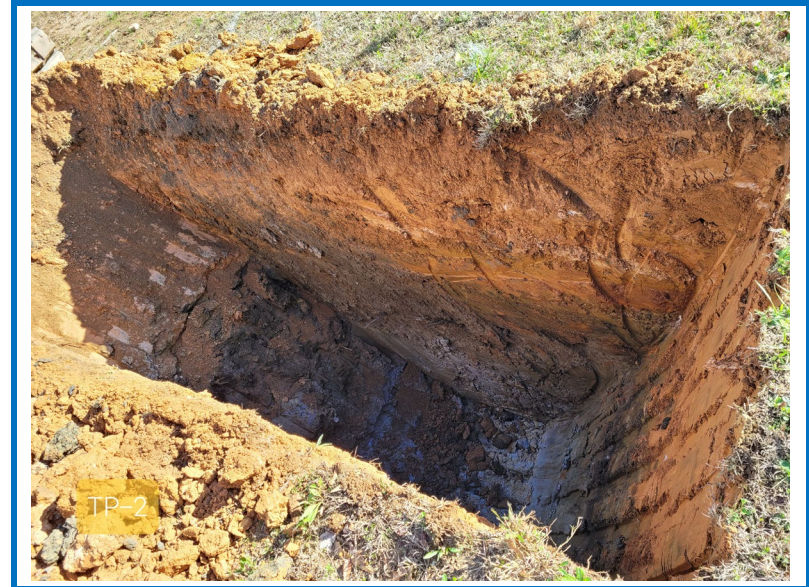
Photo 5: Test Pit TP-2

Depth (ft)	Elevation (ft)	Graphic Log	Visual Classification and Remarks	
	1090		Topsoil - some gravel Sand - clayey, reddish brown with white (fill)	0.2
5	1085		Trace cobbles, trace roots, trace organics, trace brick fragments, grayish brown, organic odor	
			Clay - sandy, trace roots, moist to wet, light gray (alluvium)	8.0
10			Test Pit Terminated at 10 feet	10.0

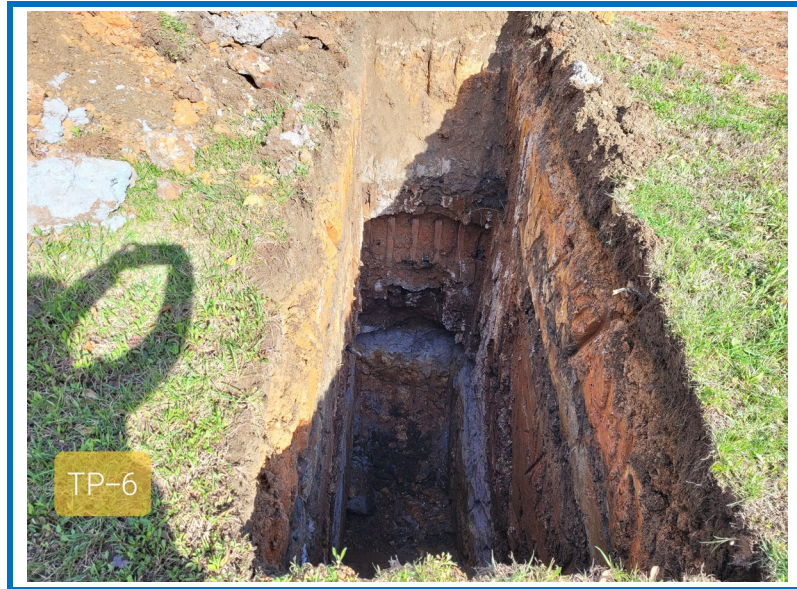
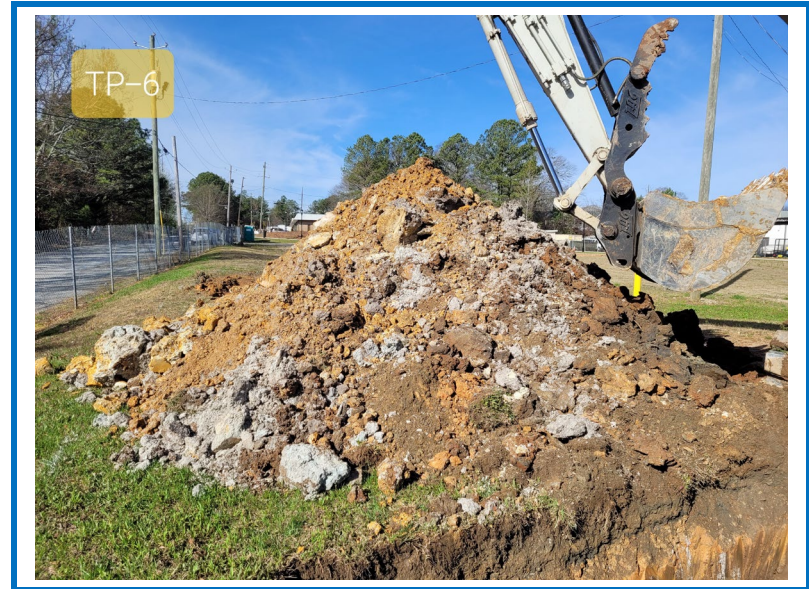
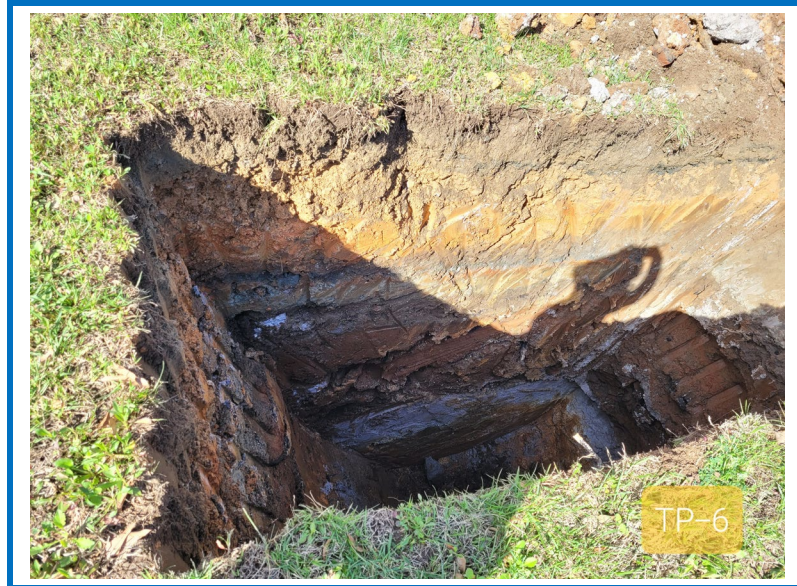
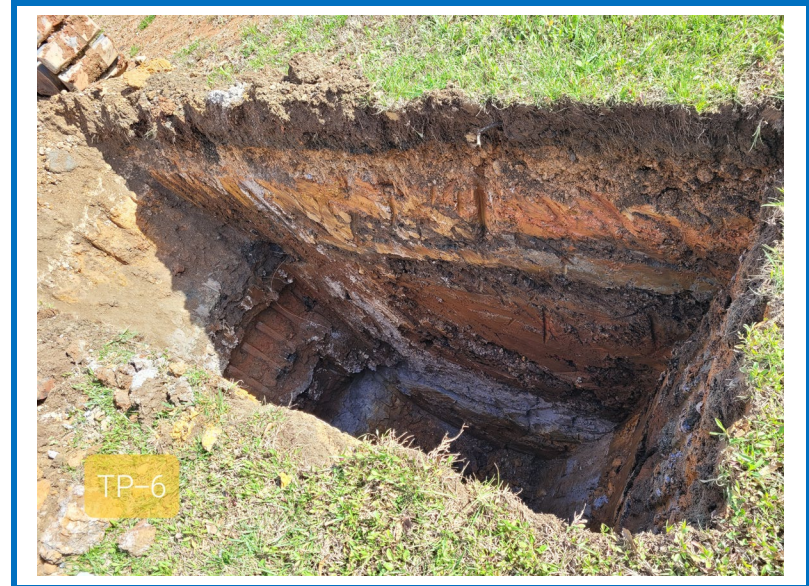
Photo 21: Test Pit TP-6

Depth (ft)	Elevation (ft)	Graphic Log	Visual Classification and Remarks	
			Topsoil - gravelly	1.0
			Sand - clayey, trace rock fragments, light reddish brown (fill)	
			Sand - some clay, trace rock fragments, trace concrete, trace cobbles, organic odor, grayish brown	
5	1085		Clay - sandy, trace concrete, trace boulders, trace asphalt fragments, dark reddish brown	5.0
10	1080		Sand - clayey, light gray (alluvium)	10.0
15	1075		Clay - sandy, moist, light gray and orangish tan (residuum)	13.0
			Test Pit Terminated at 17 feet	17.0

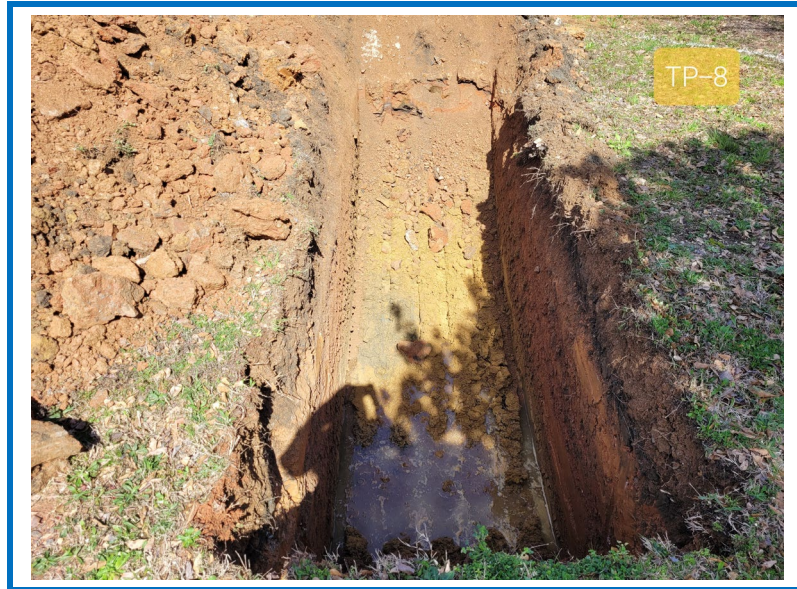
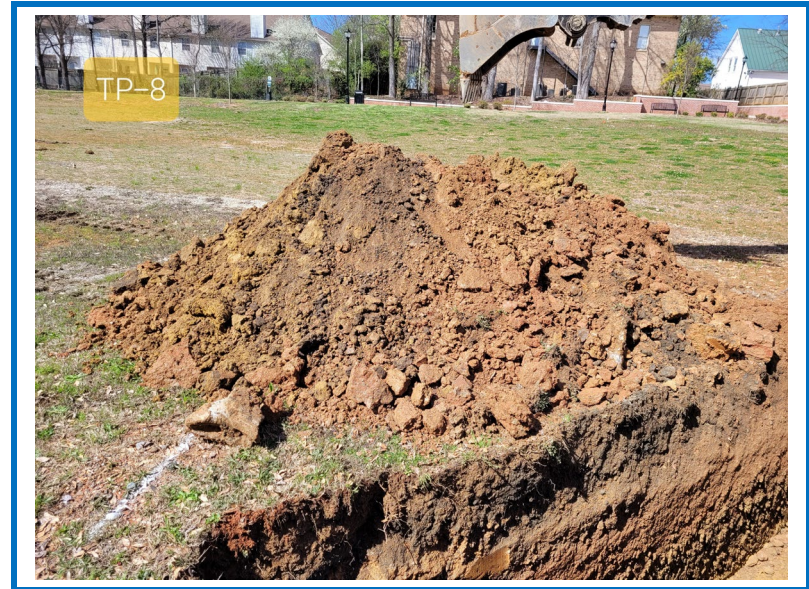
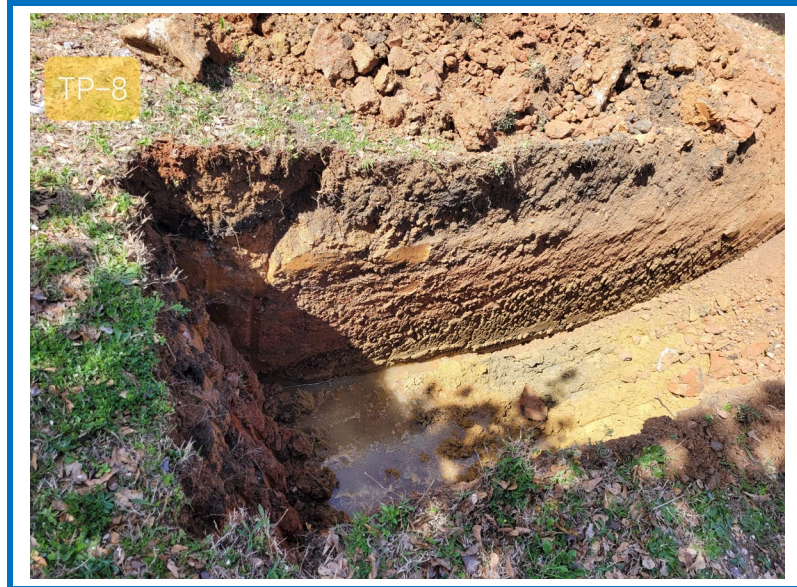
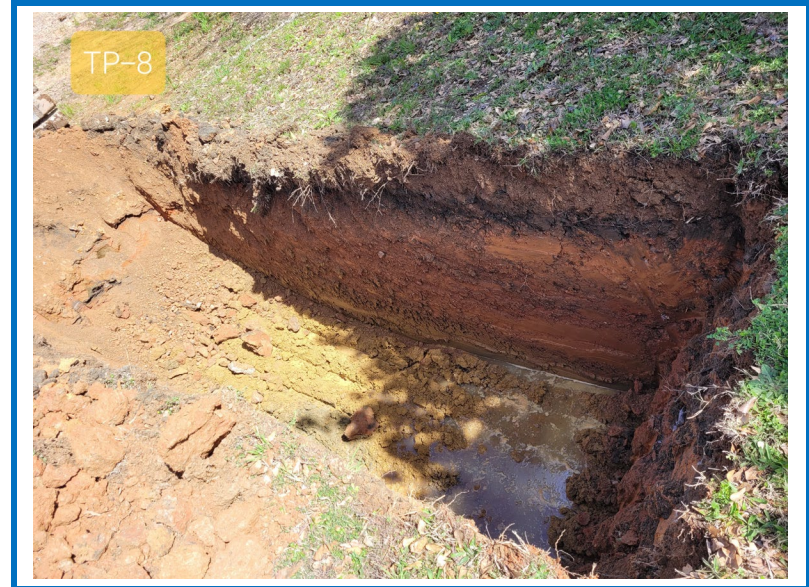
Photo 29: Test Pit TP-8

Depth (ft)	Elevation (ft)	Graphic Log	Visual Classification and Remarks	
	1090		Topsoil - some gravel	1.0
			Sand - clayey, trace rock fragments, trace cobbles, trace roots, reddish brown and tan (fill)	4.0
			Clay - sandy, moist to wet, tannish brown	5.0
			Possible gravel utility backfill	5.5

Test Pit Terminated at 5.5 feet to Avoid Possible Damage to Utility

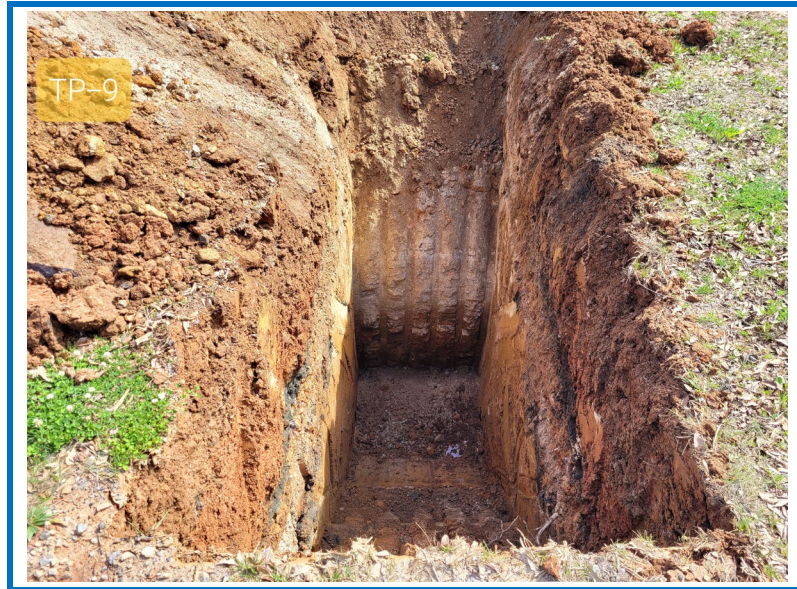
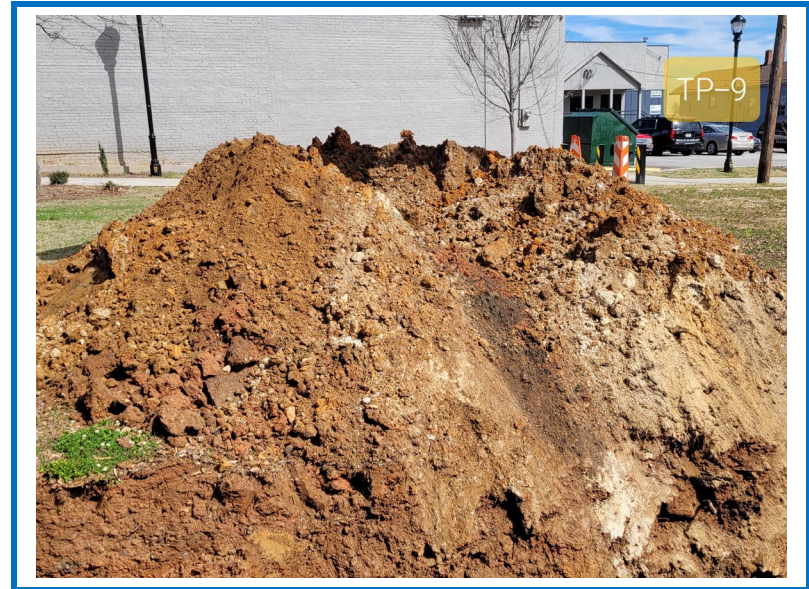
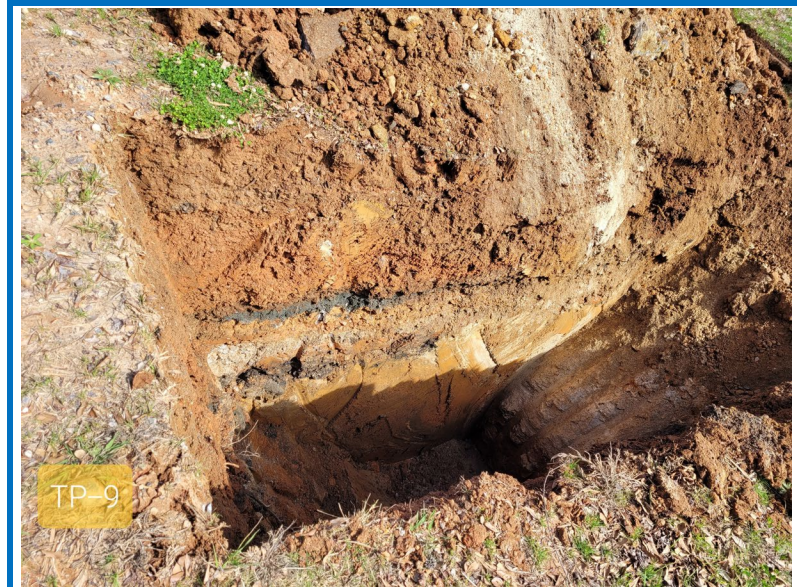
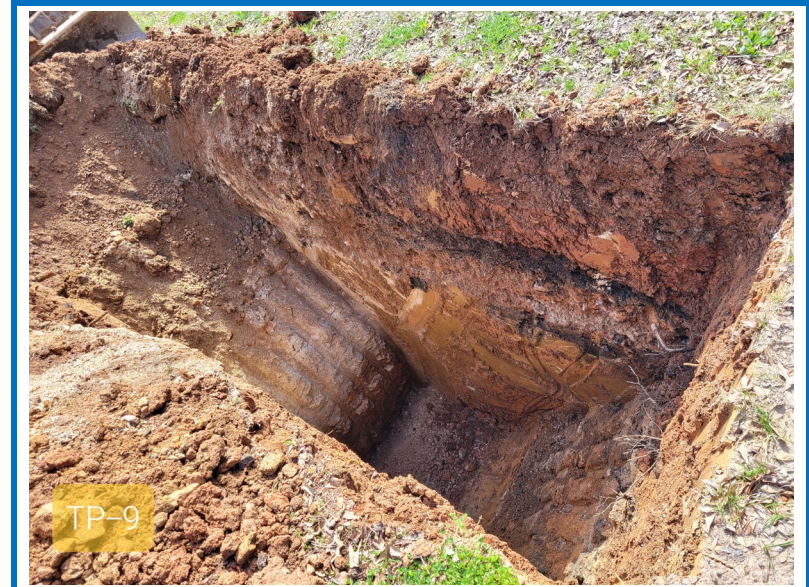
Photo 33: Test Pit TP-9

Depth (ft)	Elevation (ft)	Graphic Log	Visual Classification and Remarks	
	1095		Sand - clayey, trace rock fragments, trace concrete, trace cobbles, trace boulders, dark reddish brown (fill)	
5			Trace roots, trace asphalt fragments, reddish brown and tan, with lenses of dark gray gravelly sand at bottom and top of layer	5.0
	1090		Silt - some sand, trace mica, moist, orangish brown (residuum)	
			Silt - sandy, trace mica, moist, orangish brown	
10			Test Pit Terminated at 10 feet	10.0

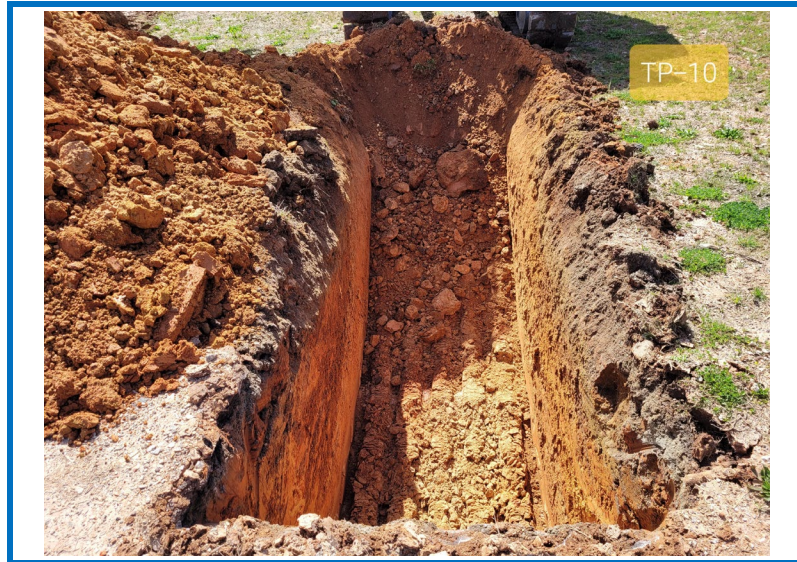
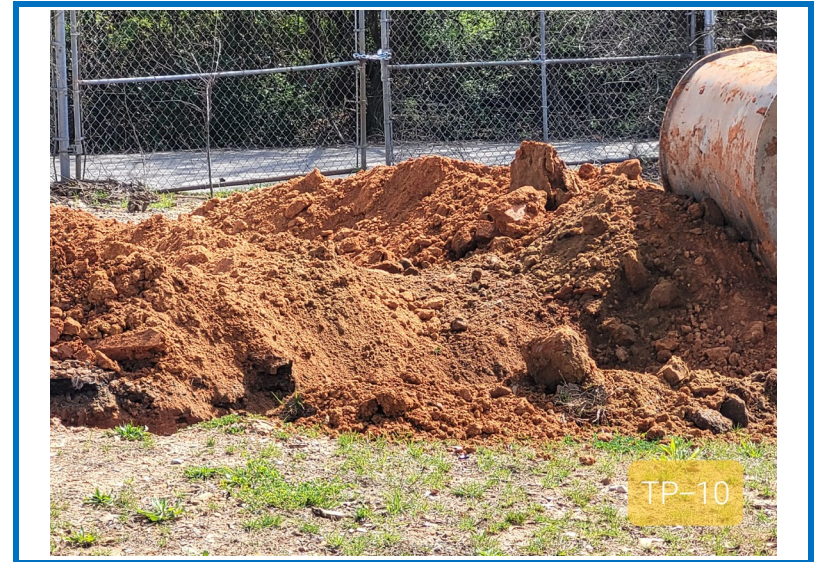
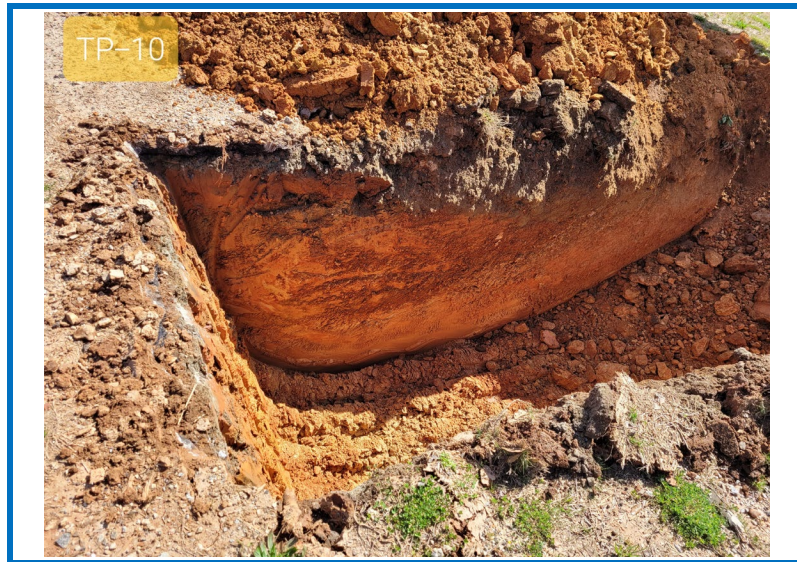
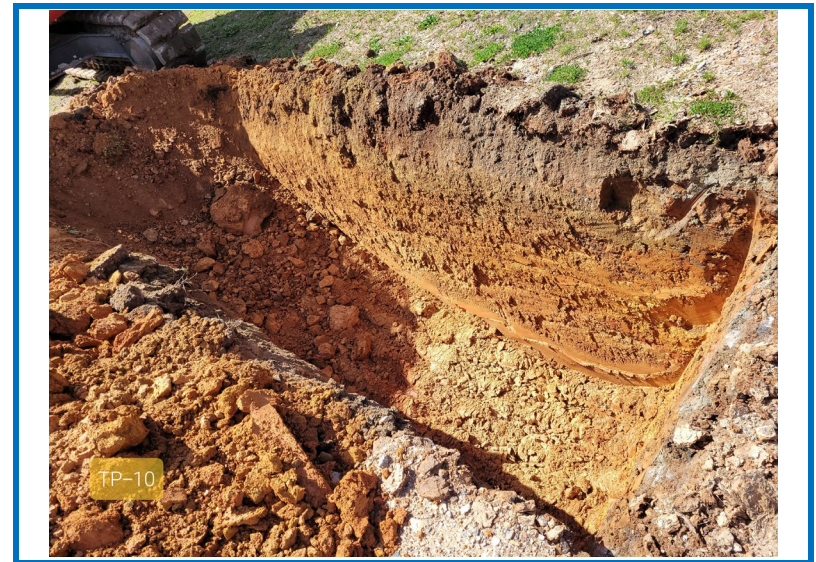
Photo 37: Test Pit TP-10

Depth (ft)	Elevation (ft)	Graphic Log	Visual Classification and Remarks	
			Topsoil - some gravel Clay - sandy, reddish brown (fill)	0.2
	1090		Sand - clayey, some silt, trace mica, reddish brown and tan (residuum)	2.0
5			Sand - silty, trace mica, reddish brown and tan	6.0
