Lake Erin Dam Rehabilitation

Basis of Design Report
NID ID: GA01324

City of Tucker
DeKalb County, Georgia

September 13, 2024

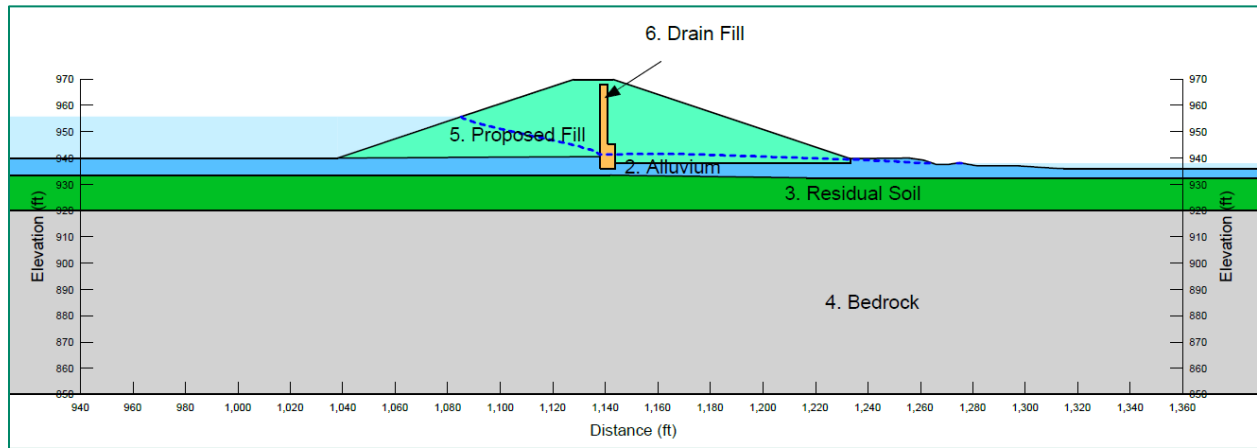
An schematic of the maximum cross section and offset cross section are shown in **Figure 3** and **Figure 4**.

Figure 3: Maximum Embankment Cross Section

For the modeled proposed embankment cross sections, the critical (lowest) slope stability factors of safety and the respective USACE, and Georgia State regulations minimum required factors of safety are presented in **Table 6** for the cross section adjacent to the principal spillway conduit and in **Table 7** for the offset cross section. The results of the seepage and slope stability analyses are provided in **Appendix B** of this report.

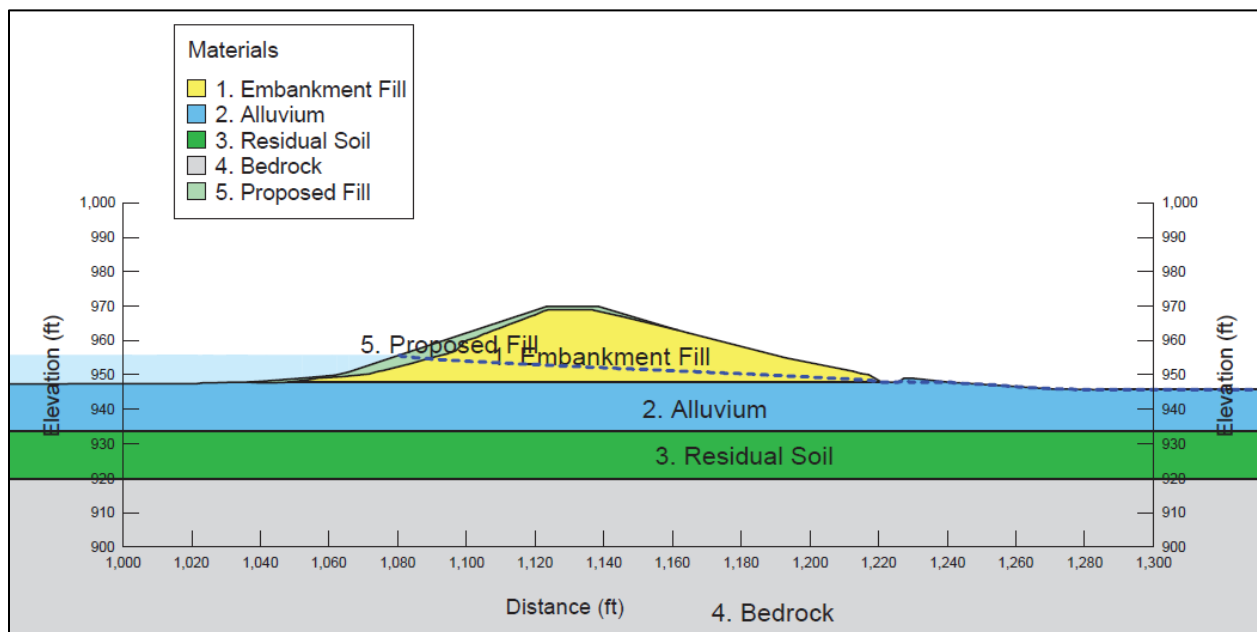
Figure 4: 100ft Offset Cross Section

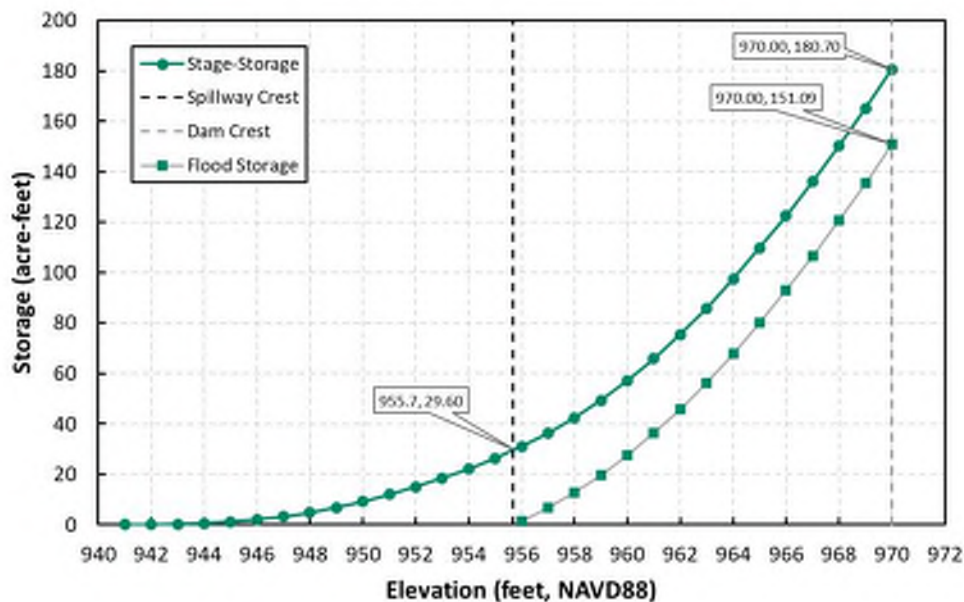
A proposed conditions model was developed to represent the proposed conditions for this rehabilitation project. The model developed in the previous H&H analysis (AECOM, 2021) was used as a starting point. The elevation discharge curve developed for the proposed intake structure was input into the hydrologic model. This rating curve was developed empirically using equations for the prevailing hydraulic regimes that are referenced in **Appendix C** of this report. During the SDF event, the 48-inch principal spillway conduit will control the discharge from the reservoir and the riser structure will be submerged. The hydrologic inputs and the precipitation inputs are not expected to change and therefore, were not revised. The elevation storage rating for the reservoir was updated to reflect the proposed conditions. The elevation storage rating for proposed conditions did not impact the results of the SDF event but did have a small impact on the resulting peak water surface elevation for 4%, 2%, and 1% AEP events. The proposed stage storage rating for the reservoir is included in **Appendix C** of this report. **Figure 5** shows stage-storage rating for the proposed reservoir conditions. There was one error found with the previous H&H analysis where the curve number for the land cover types of developed (medium intensity) and forest were swapped. Since the Lake Erin watershed has a larger area of developed (medium intensity) than forested area, this error resulted in the curve number being underestimated. The calculations were revised to assign the correct curve number to both land cover types, which resulted in the composite curve number increasing by 3. The revised curve number was used in the existing and proposed conditions model. **Figure 6** shows a comparison of the elevation-discharge ratings for the existing and new principal spillways.

Figure 5: Elevation-Storage Rating for Proposed Conditions

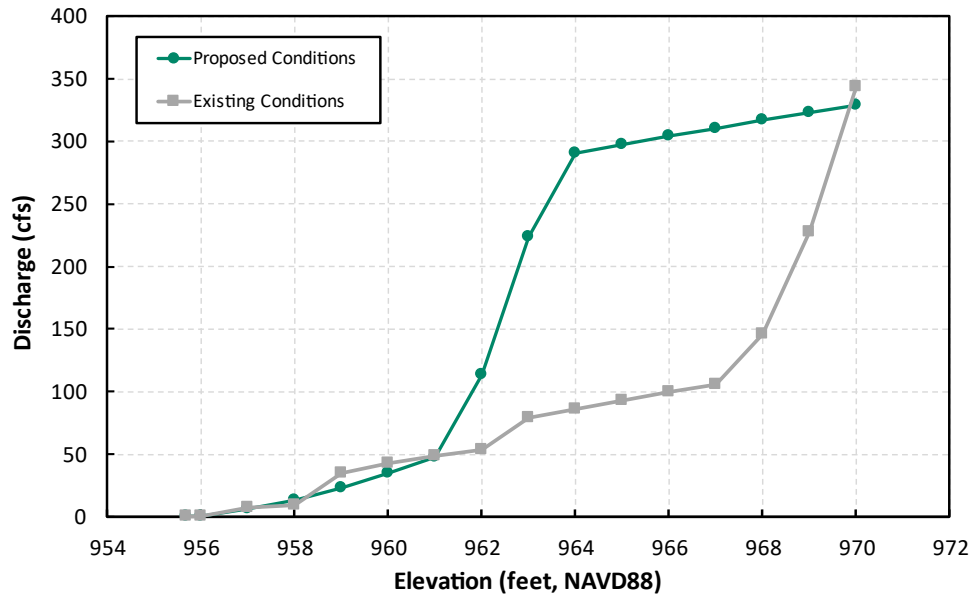
Figure 6: Elevation-Discharge Ratings for Existing and Proposed Principal Spillway

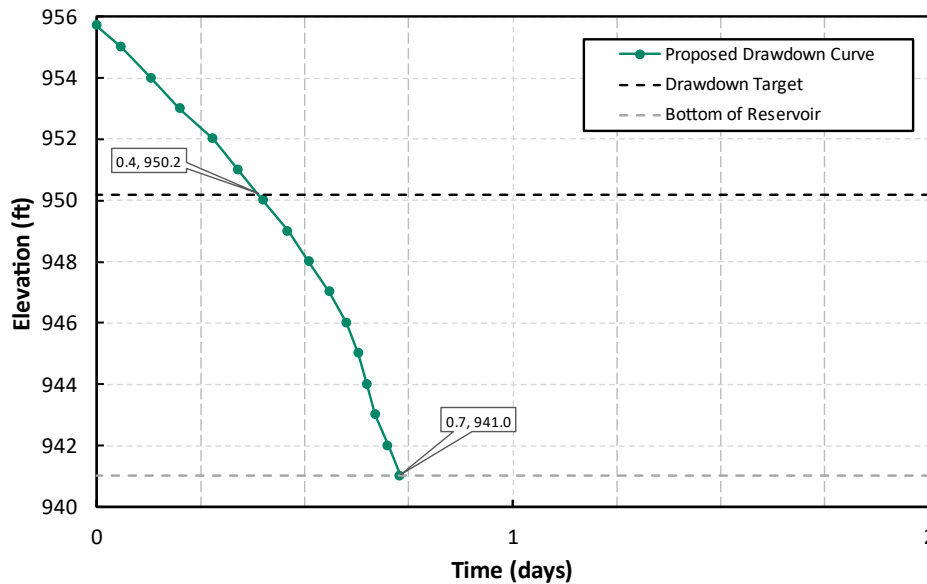
Reclamation Design of Small Dams (USBR, 1987) Chapter 10 Outlet Works. Based on the guidance in Chapter 10, it is estimated that the proposed low-level outlet system could meet the drawdown requirement in just under 10 hours if fully operated. The entire reservoir can be emptied from normal pool in just under 17 hours if fully operated. It is important to note that AECOM recommends the maximum drawdown rate not exceed 1 foot per day, which would completely drain the reservoir in approximately 5.5 days. See **Figure 7** below for the reservoir drawdown curve under proposed conditions.

Figure 7: Proposed Drawdown Rating Curve

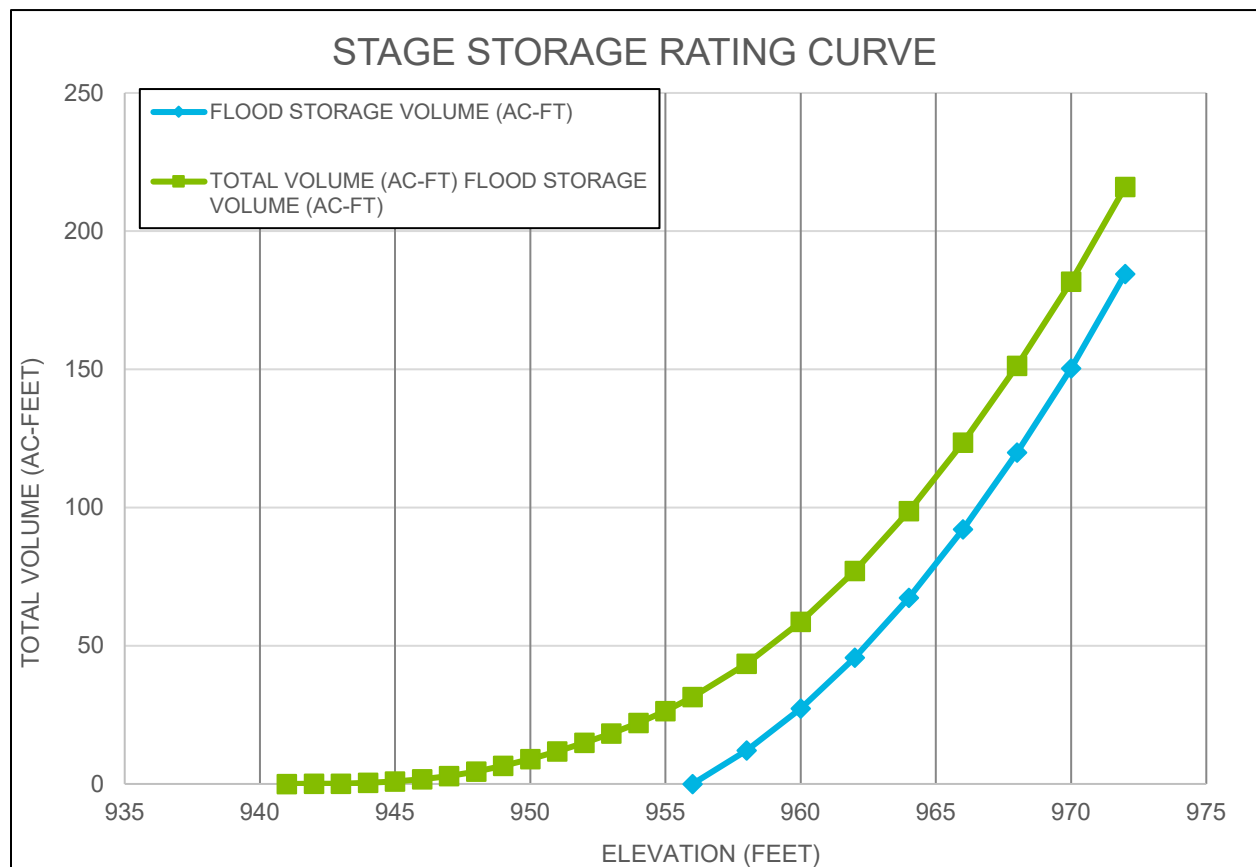
The bathymetric survey aided the development of the stage storage curve for Erin Lake Dam. The contours from the survey as well as those contained in the 2011 LiDAR data for DeKalb County were used to develop the stage-storage rating provided in Figure 2 below. Related calculations and tabular ratings can be found in Appendix D.

Figure 2. Stage-storage rating curve.

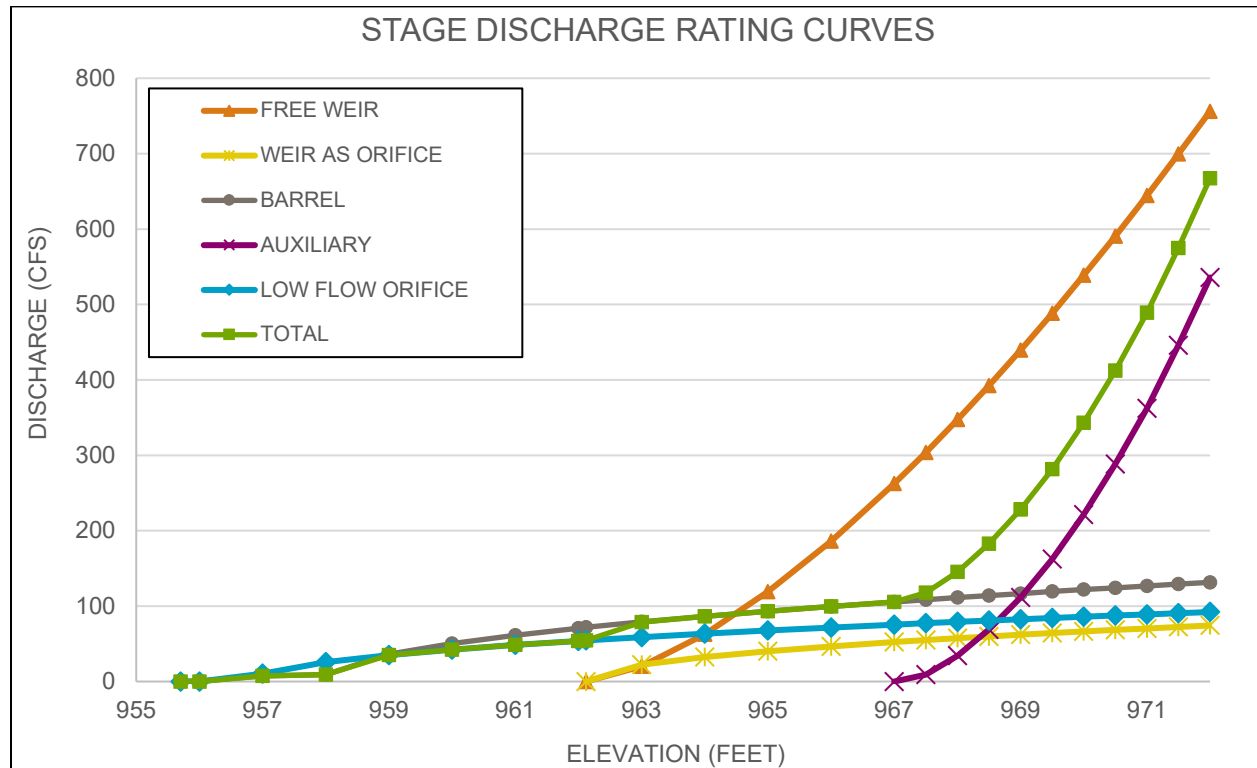
The stage discharge rating curve was developed by comparing a series of ratings for each of the dam’s spillway components. The principal spillway was evaluated for low flow orifice, free weir, submerged weir, weir as orifice, and barrel/conduit control to determine a composite rating. The composite rating indicates that the principal spillway is controlled by its inlet at elevation (EL.) 955.70 feet and operates in conduit control. It operates in low flow orifice control between EL. 958.00 feet and EL. 962.12 feet (the crest of the riser pipe) before transitioning to conduit control again. The auxiliary spillway discharge rating was developed by modeling the spillway as an open channel using gradually

varied flow regime modeling procedures defined in *Open Channel Hydraulics* (Chow, 1959). The principal and auxiliary spillway ratings were added together to create the overall stage-discharge rating for the dam. The total discharge and individual discharge components are shown in Figures 3 and 4. Related calculations and tabular ratings can be found in Appendix D.

Figure 3. Stage-discharge rating curves.

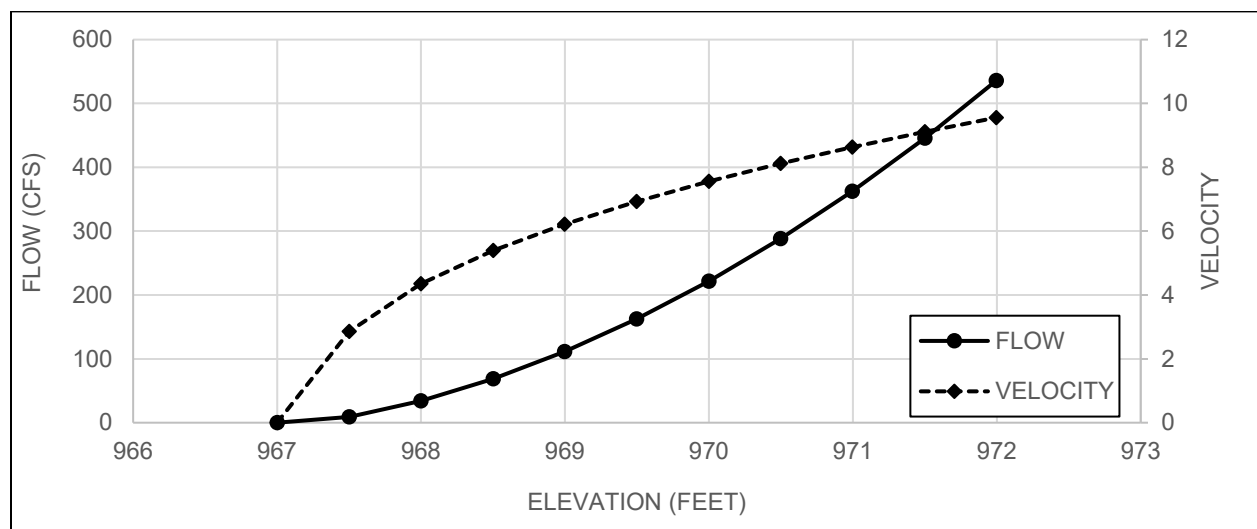
Figure 4. Auxiliary spillway stage-discharge rating curve.

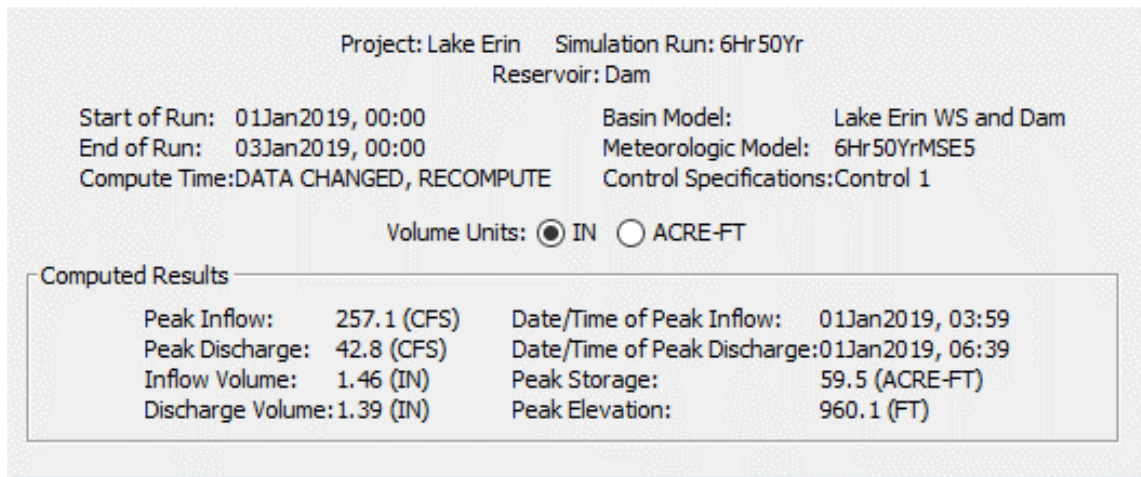
The two precipitation events defined in Section 2.1 were modeled using U.S. Army Corps of Engineers' (USACE) HEC-HMS version 4.7.1. Both storm events had the same hydrologic model parameters applied to them. The results show that the 50-year event has a peak water surface elevation of EL. 960.1 feet which indicates that the auxiliary spillway won't be activated during this event. The SDF event has a peak water surface elevation of EL. 969.2 feet which exceeds the dam crest elevation of EL. 968.5 feet and doesn't provide any freeboard. The results are displayed in Figures 5 and 6 below.

Figure 5. 50-year flood routing results.

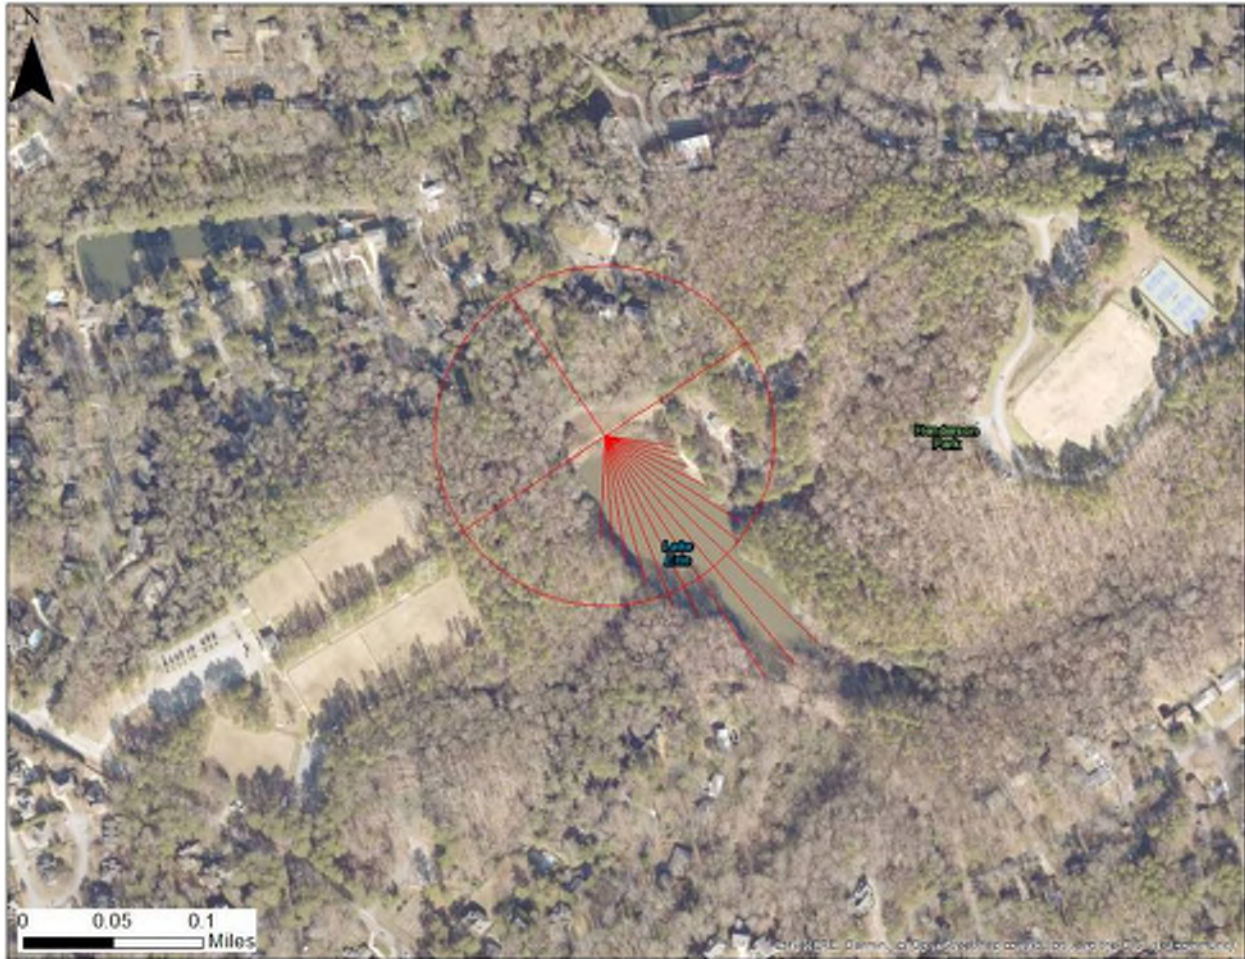
A freeboard analysis was performed for Erin Lake Dam using methodologies described in NRCS Technical Release 56 (NRCS, 2014). The effective fetch was evaluated at a location as shown in Figure 7 on the dam and determined to be 500 feet or approximately 0.095 miles.

Figure 7. Effective fetch calculation lengths.

The overland wind velocity was determined using the guidance to be approximately 85 miles per hour (mph). It should be noted that SDP requires a minimum overland wind velocity of 50 mph. Based on the fetch, the over water wind velocity was determined to be approximately 87 mph. The estimated significant wave height (and recommended freeboard height) based on the over water wind velocity and effective fetch is 0.8 feet. It is noted that if the SDP recommended overland wind velocity of 50 mph is considered, the recommended freeboard height would be approximately 0.5 feet. Freeboard calculations can be found in Appendix F.

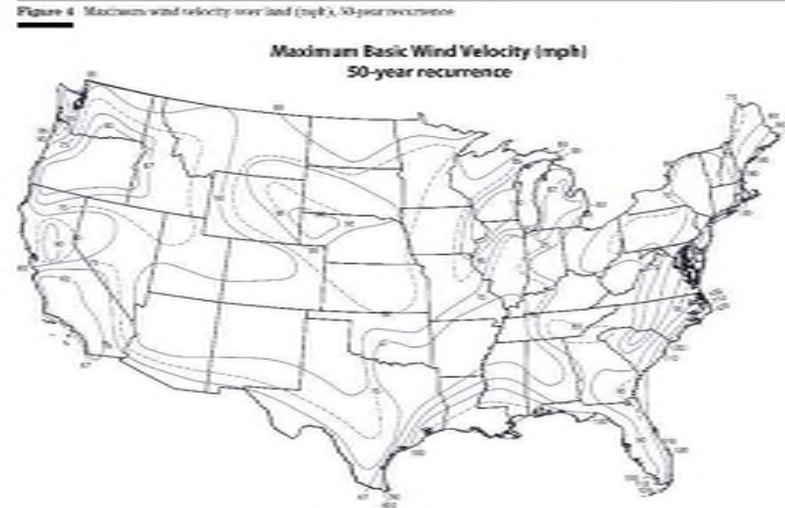
Figure 4 Maximum wind velocity overland (mph), 50-year recurrence

Step 2: Estimate 50-year recurrence overland wind velocity from NRCS TR-56 (Fig. 4).

V_L (mph) =	85
---------------	----

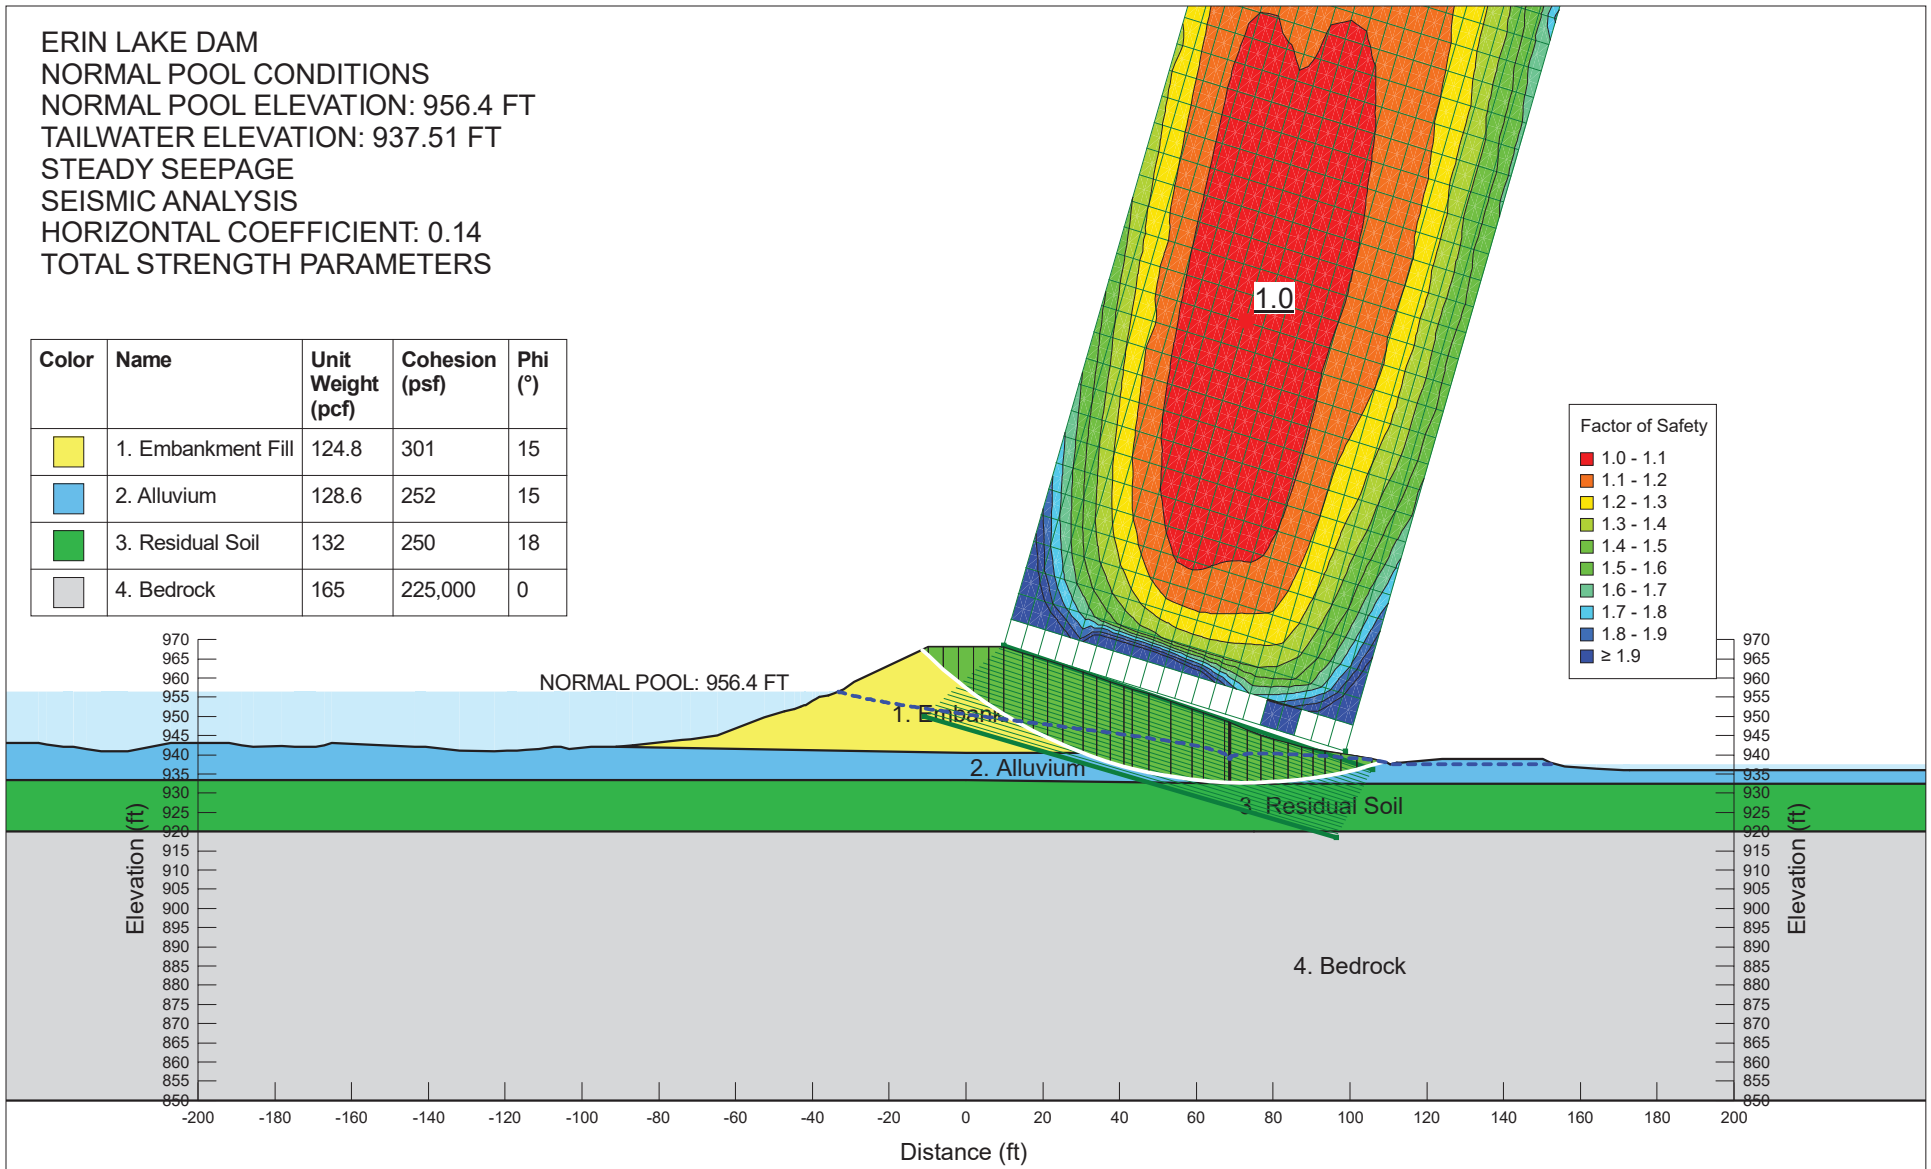
ERIN LAKE DAM
 NORMAL POOL CONDITIONS
 NORMAL POOL ELEVATION: 956.4 FT
 TAILWATER ELEVATION: 937.51 FT
 STEADY SEEPAGE
 SEISMIC ANALYSIS
 HORIZONTAL COEFFICIENT: 0.14
 TOTAL STRENGTH PARAMETERS

Color	Name	Unit Weight (pcf)	Cohesion (psf)	Phi (°)
Yellow	1. Embankment Fill	124.8	301	15
Blue	2. Alluvium	128.6	252	15
Green	3. Residual Soil	132	250	18
Grey	4. Bedrock	165	225,000	0

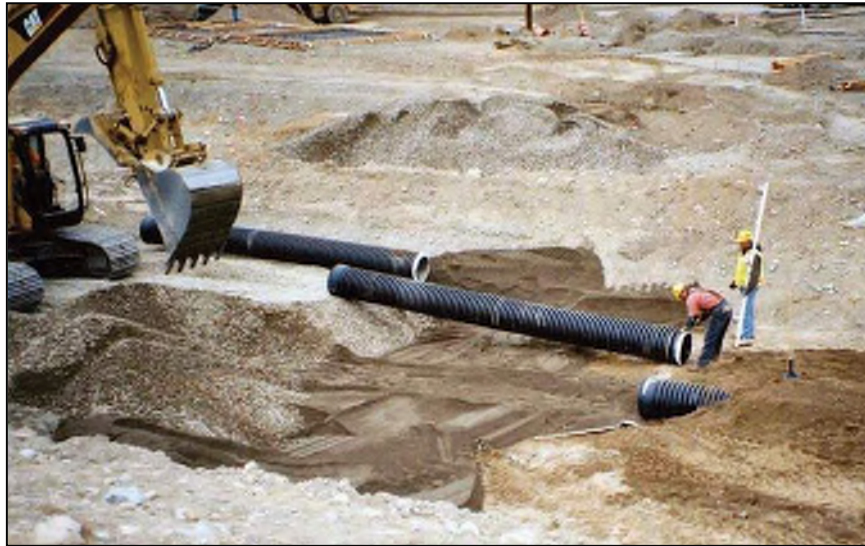
Figure 53.—Installation of profile wall corrugated pipe for a drainpipe replacement during a modification of an embankment dam.

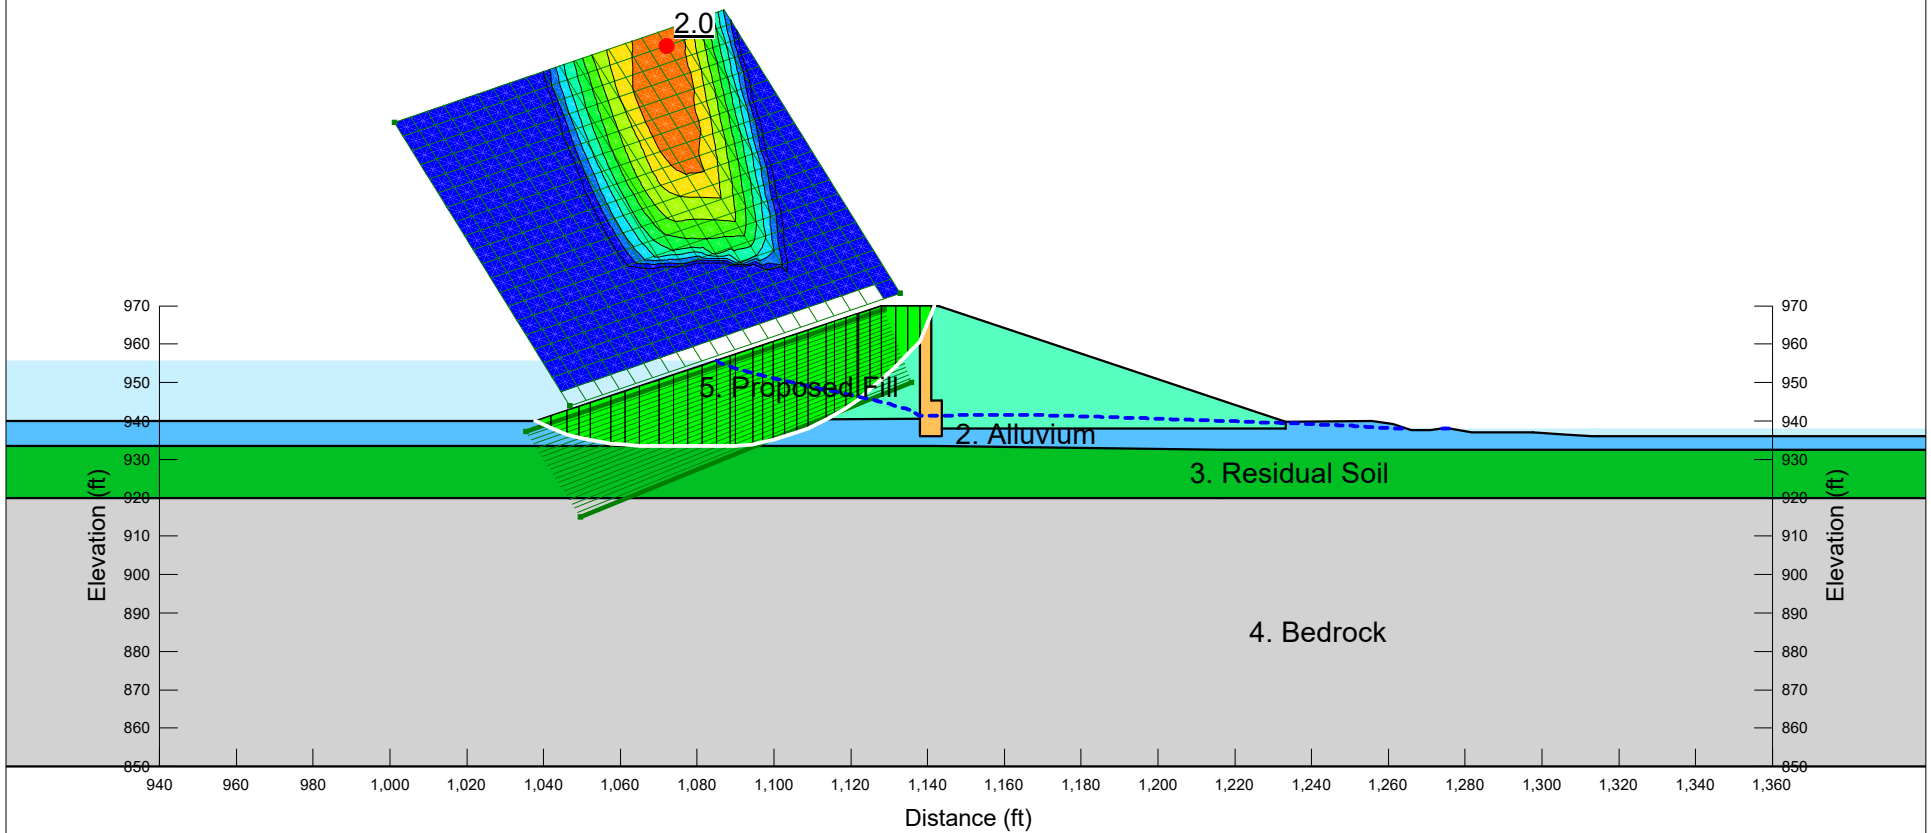
ERIN LAKE DAM- PROPOSED CONDITIONS
 END OF CONSTRUCTION - TOTAL STRENGTH PARAMETERS
 NORMAL POOL: 955.7 FT
 STEADY SEEPAGE
 SLOPE STABILITY ANALYSIS

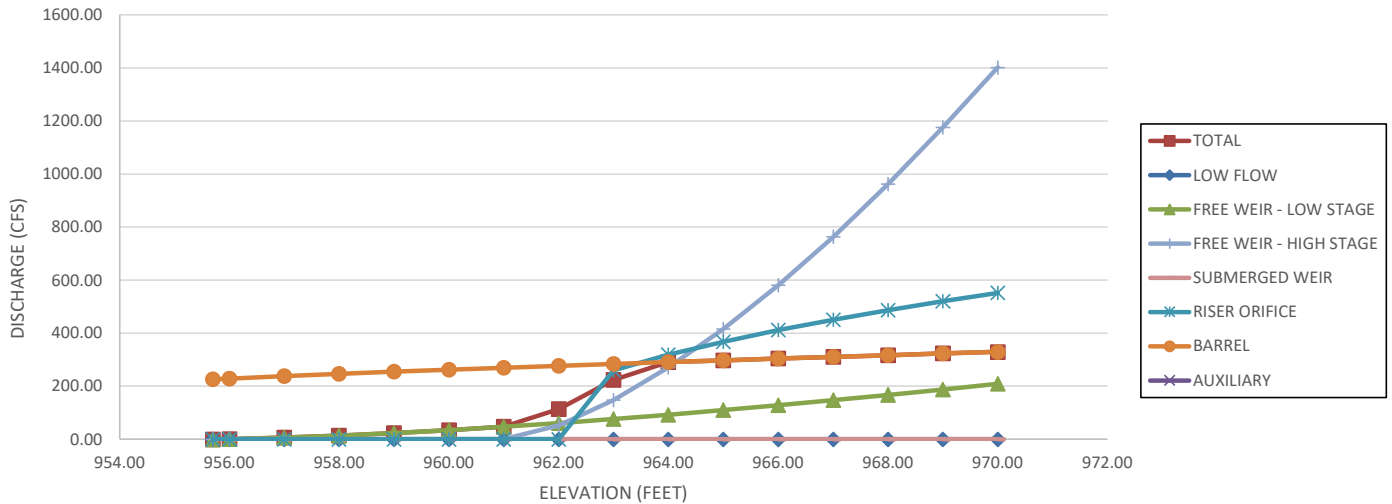
STAGE DISCHARGE RATING CURVES

Equations Used:

(1) Low Flow Orifice: $Q_0 = C_0 A \sqrt{2gH_0}$

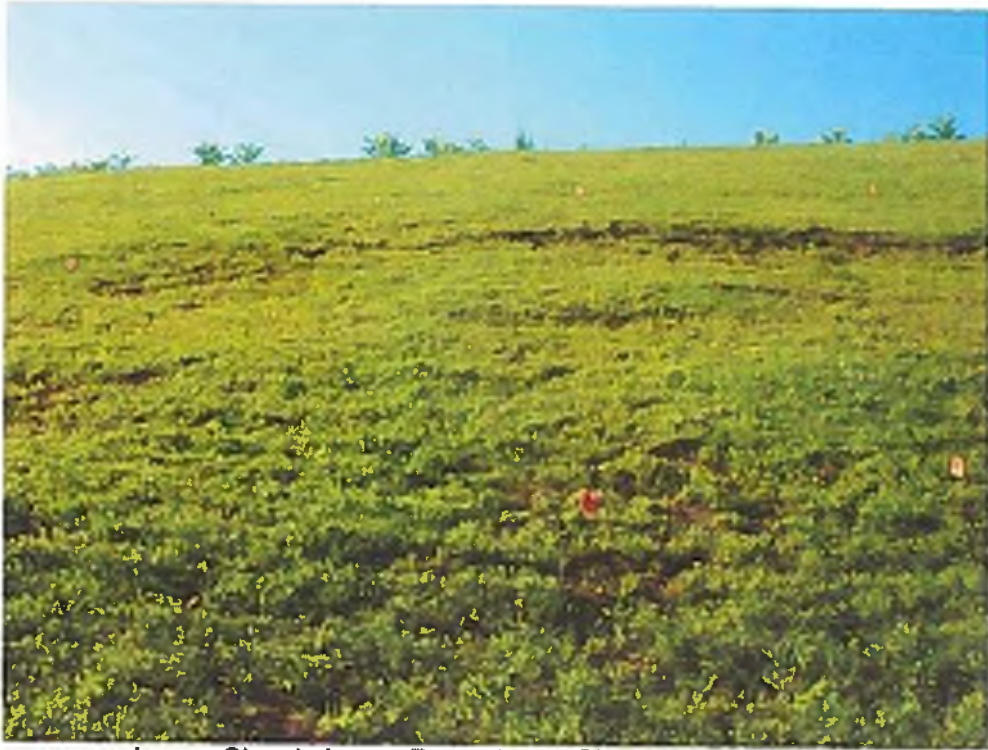
Larger Slough Area – Downstream Slope, Erin Lake Dam

Our site inspection did not indicate any major signs of instability of the dam. Two distinct "sloughs" were observed by the Willmer engineer. The sloughs roughly measured 23 feet in length by 26 feet in width and 13 feet in length by 16 feet in width. The approximate areal extent of the observed sloughs is shown on the attached topographic survey. Photographs of the sloughs are also included. An erosional hole was also observed at the base of the smaller slough. Hand probing of the downstream slope and slough areas did not reveal any "soft" conditions. Probing of the erosional hole indicated 6 to 12 inches of soft materials. The wet area noted in the inspection near the toe and emergency spillway was not evident during our visit. Probing along the downstream toe indicated relatively firm soil conditions during the July 7, 2010 site visit. The erosional hole near the rock wall of the spillway channel was also noted during the visit. The hole is currently filled with branches and other debris.

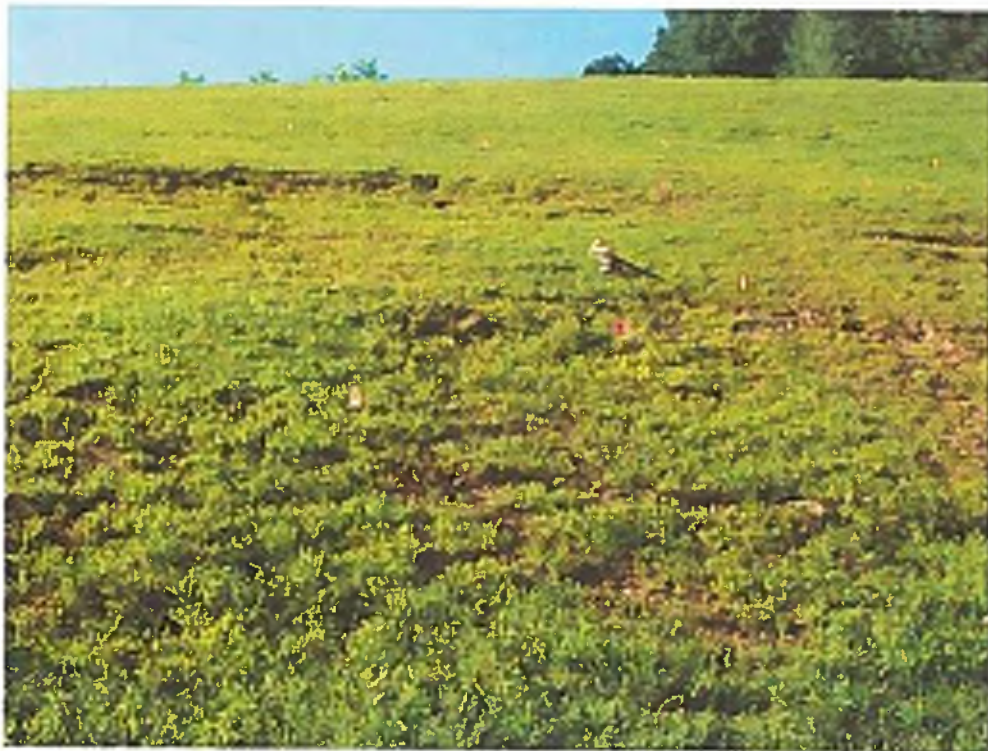
Larger Slough Area – Downstream Slope, Erin Lake Dam

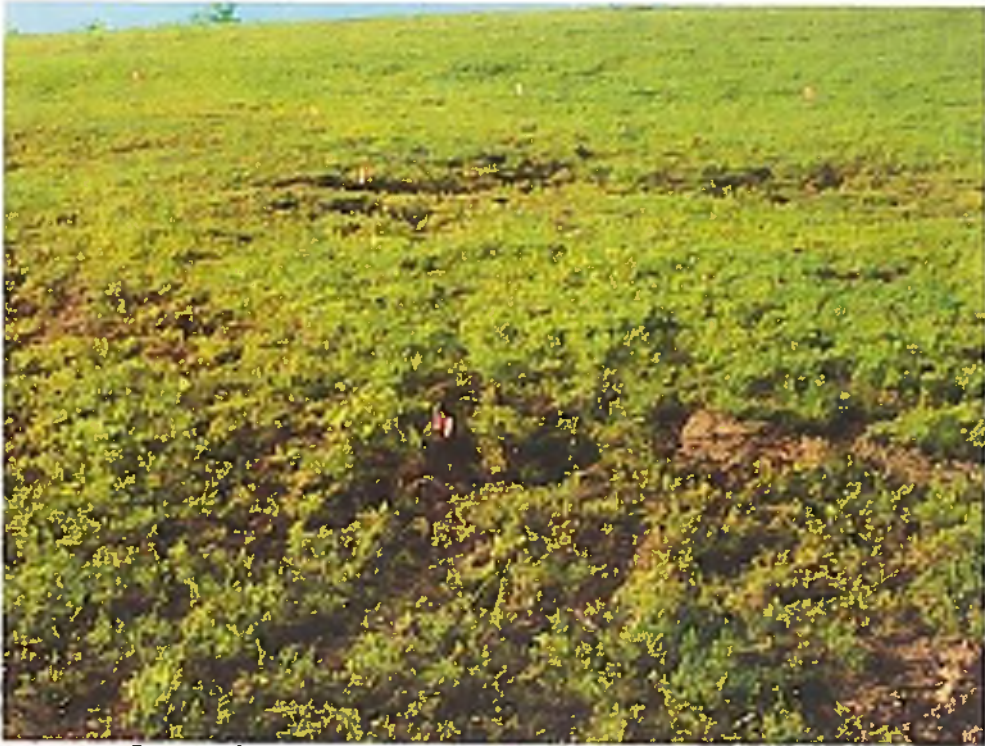
Smaller Slough Area – Downstream Slope, Erin Lake Dam

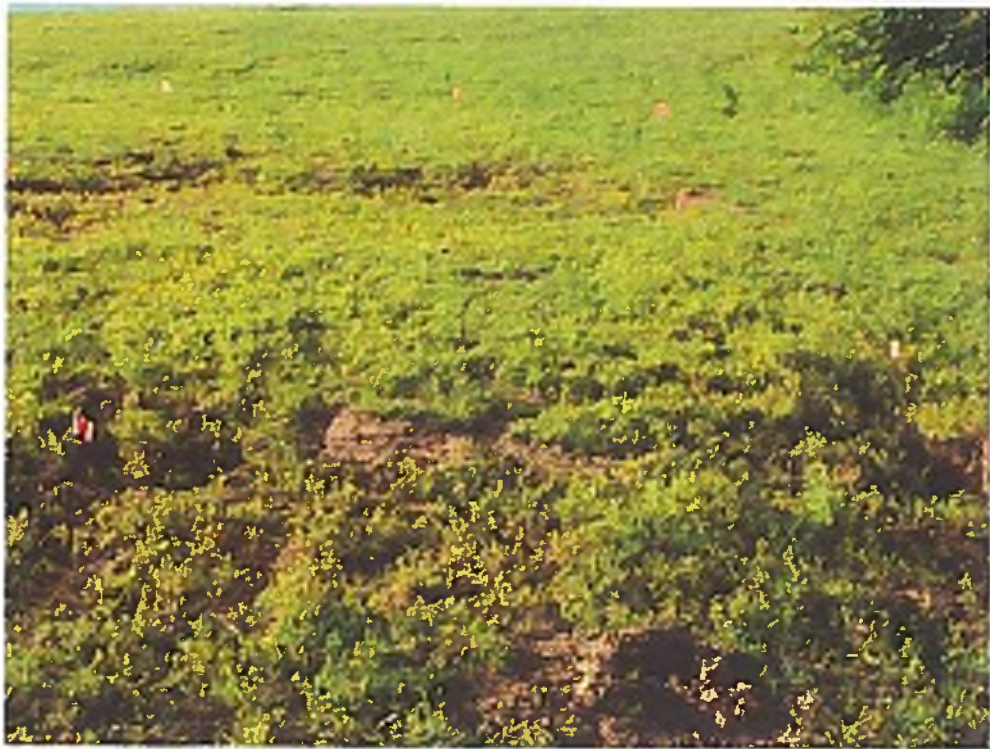
Smaller Slough Area – Downstream Slope, Erin Lake Dam

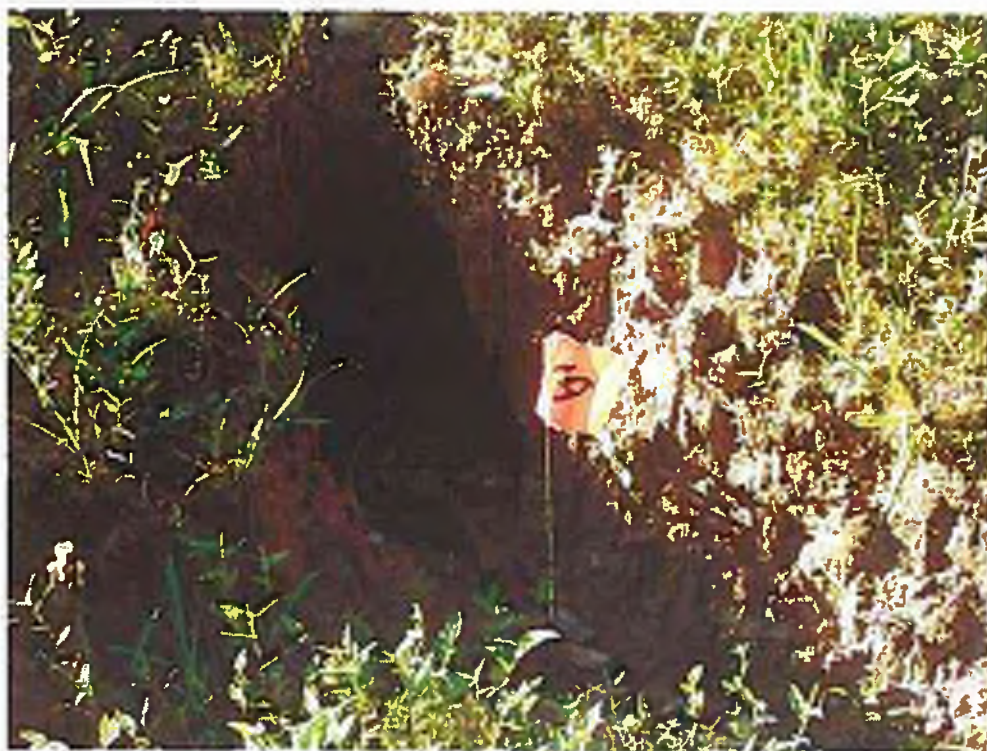
Erosional Hole at Base of Smaller Slough

Based on the observed slough conditions, it is likely the surface soils were saturated by the heavy rains of 2009 and sloughed along a shallow slip surface causing the observed failures. The erosional hole observed at the base of the smaller slough is likely the result of concentrated surface runoff. There is no physical evidence of a deeper failure occurring.

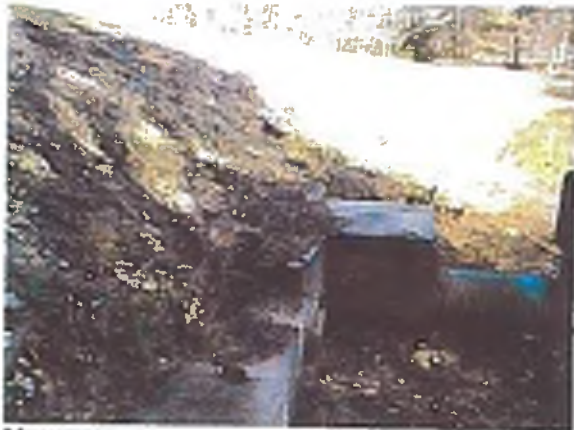
Upstream slope

1. The vegetation on the dam had been cut. Vegetation on the upstream slope needs to be replaced by low growing grass and maintained. There are animal holes on the upstream slope. These holes need to be filled and compacted.

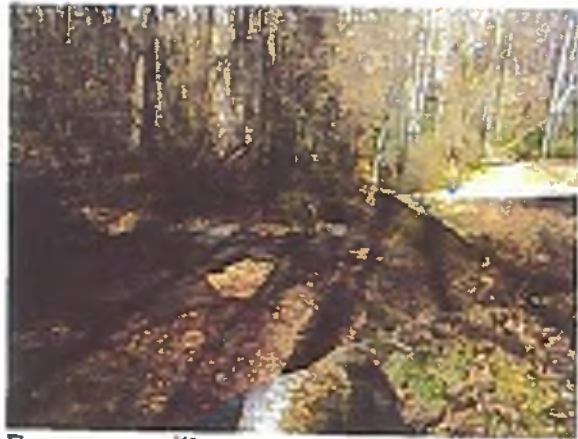
Emergency spillway channel

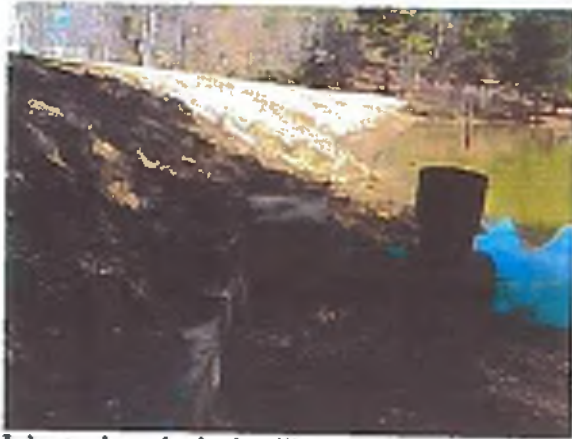
Inlet to the principal spillway pipe

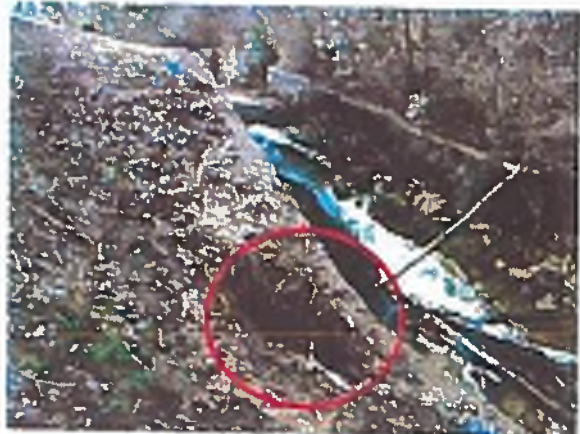
Hole at the right wing-wall of emergency spillway

4. There is a hole along the right end of the downstream channel of the emergency spillway. This should be evaluated by the EOR and repaired.
5. There is a wet area on the downstream slope, near the toe and emergency spillway channel. This area needs to be monitored for any changes.

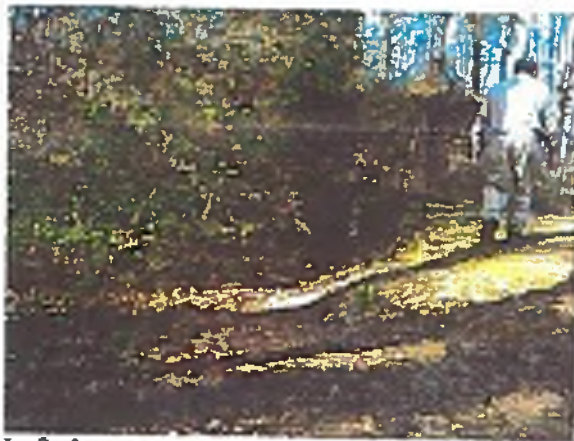
Left abutment

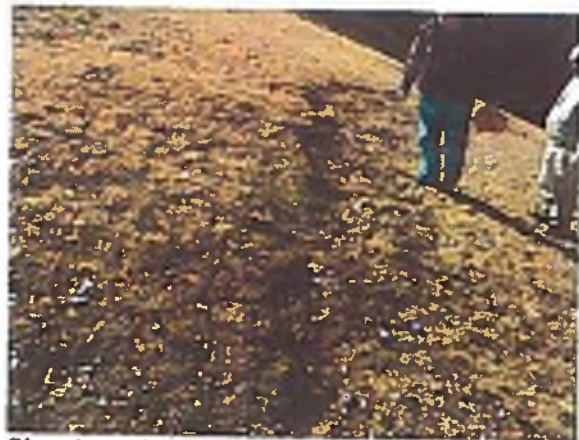
Slough on the downstream slope (mid-section)

2. There are some sparse areas of vegetation on the dam. These areas need to be seeded with a low growing grass.
3. There is a potential slough on the downstream slope, at the midsection. You will need to monitor this area for any changes. An Engineer of Record (EOR) should evaluate the slough and recommend repairs.

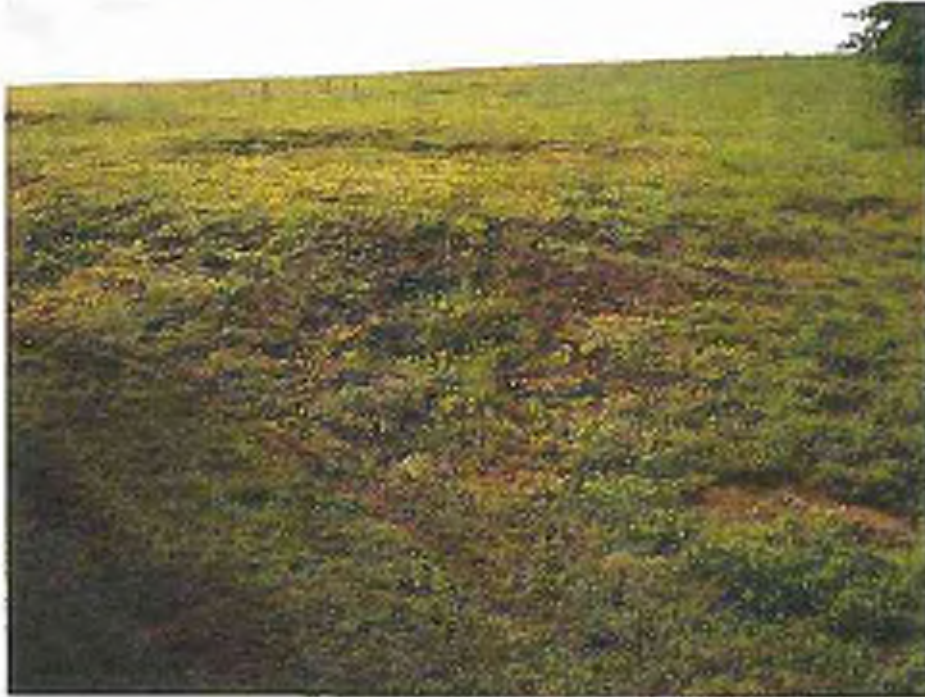
Western slough area and erosion hole; photographed on 3/14/2009

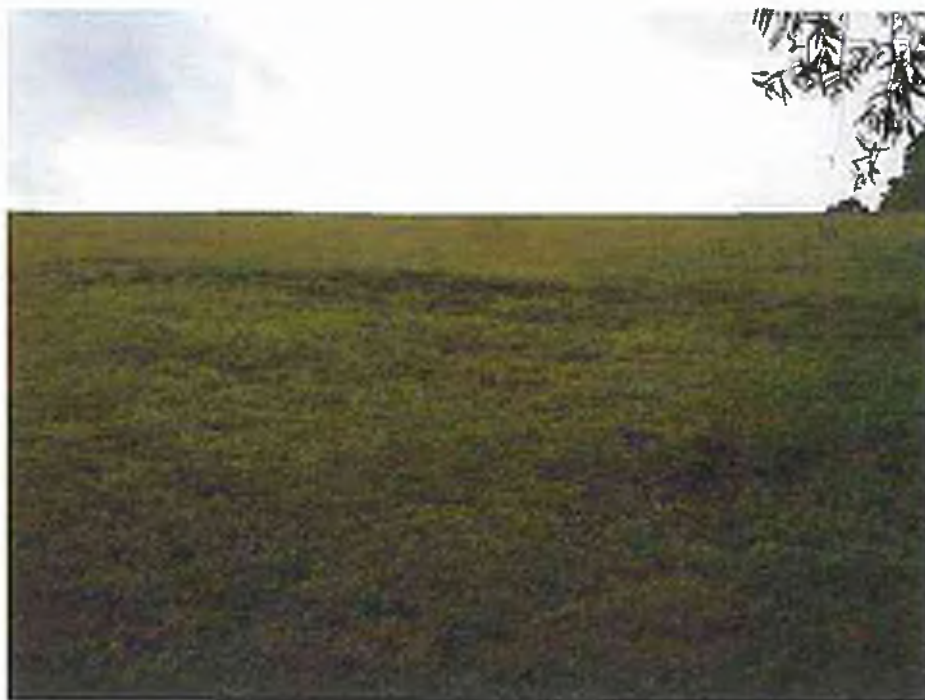
Eastern slough area; photographed on 3/14/2009

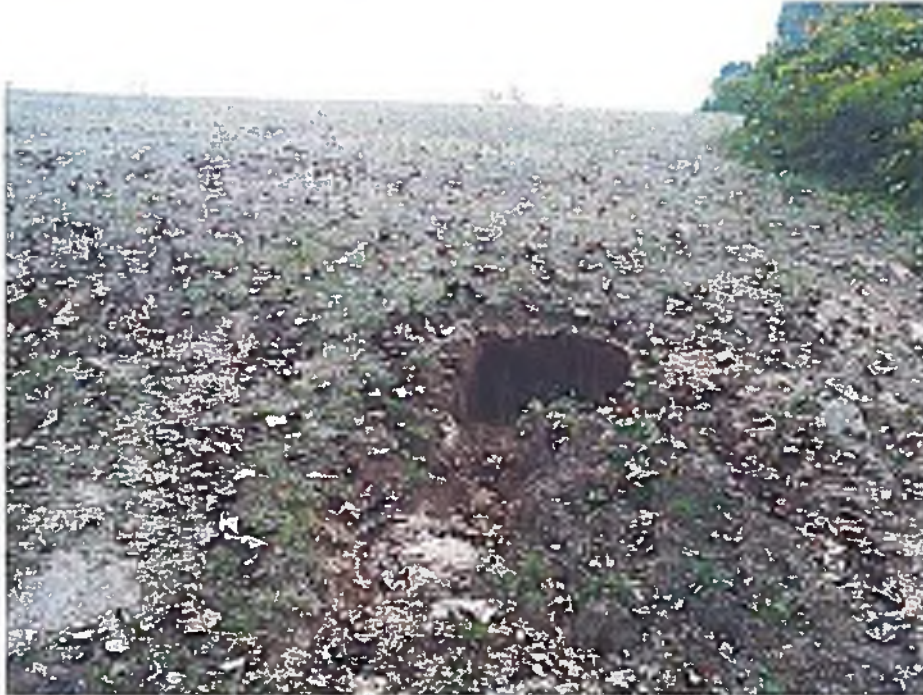
Erosion hole; photographed on 10/28/2013
