Lake Erin Dam Rehabilitation

Basis of Design Report
NID ID: GA01324

City of Tucker
DeKalb County, Georgia

September 13, 2024

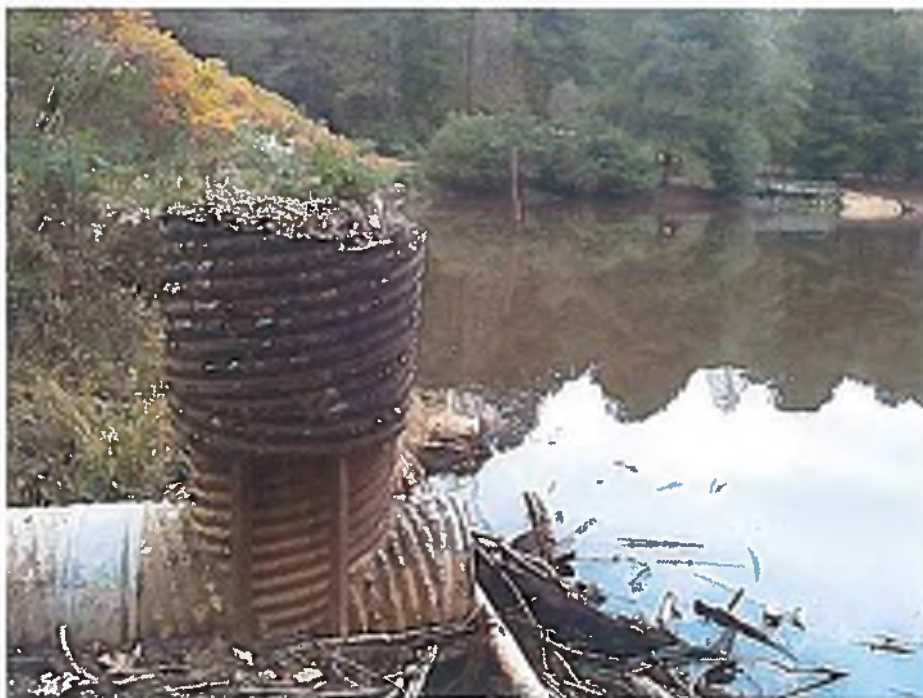
Principal spillway inlet and riser pipe; photographed on 10/28/2013

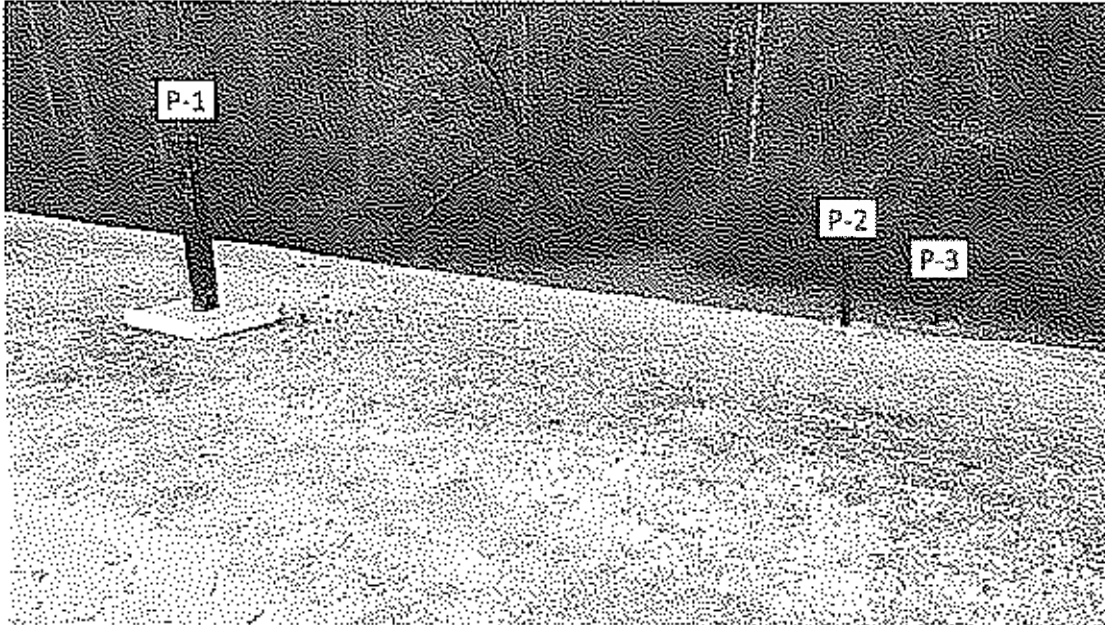
Piezometers P-1 through P-3; photographed on 12/6/2013

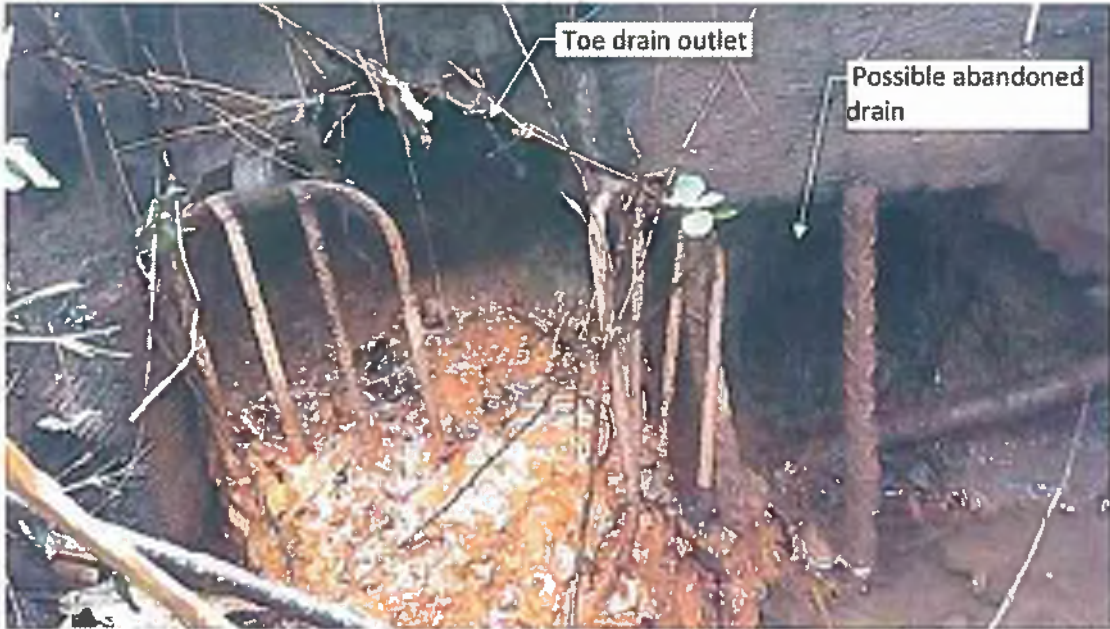
Toe drain outlet (left) and possible abandoned drain (right); photographed on 1/10/2014

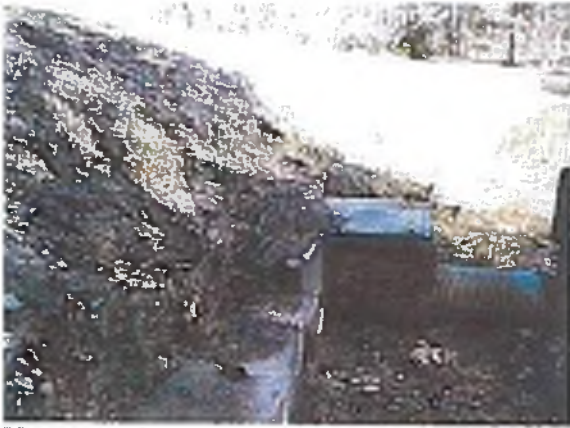
Upstream slope

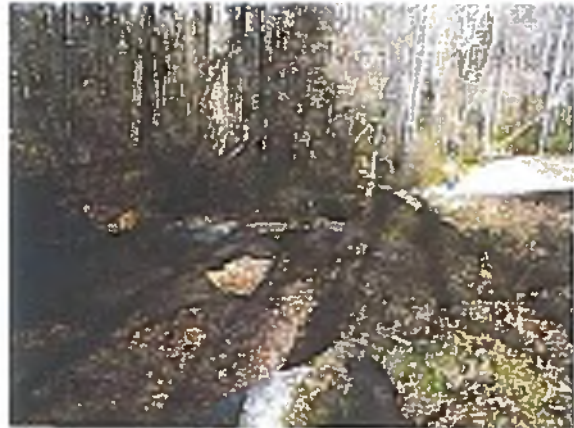
Emergency spillway channel

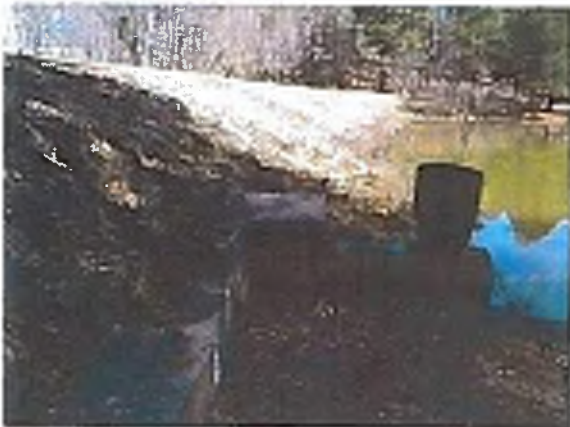
Inlet to the principal spillway pipe

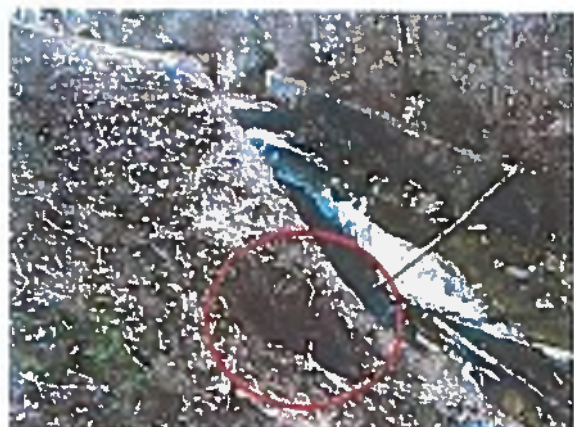
Hole at the right wing-wall of emergency spillway

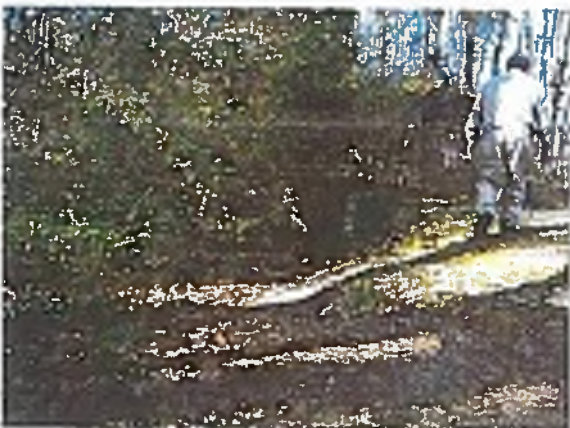
Left abutment

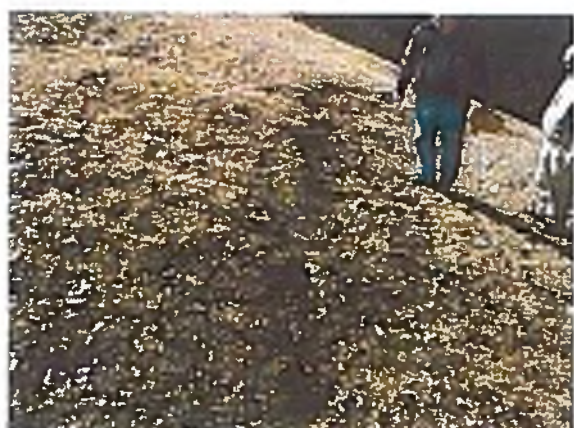
Slough on the downstream slope (mid-section)

1. The proposed remediation for the two sloughs on the downstream is to excavate the low quality material and replace with competent, well-compacted soil.

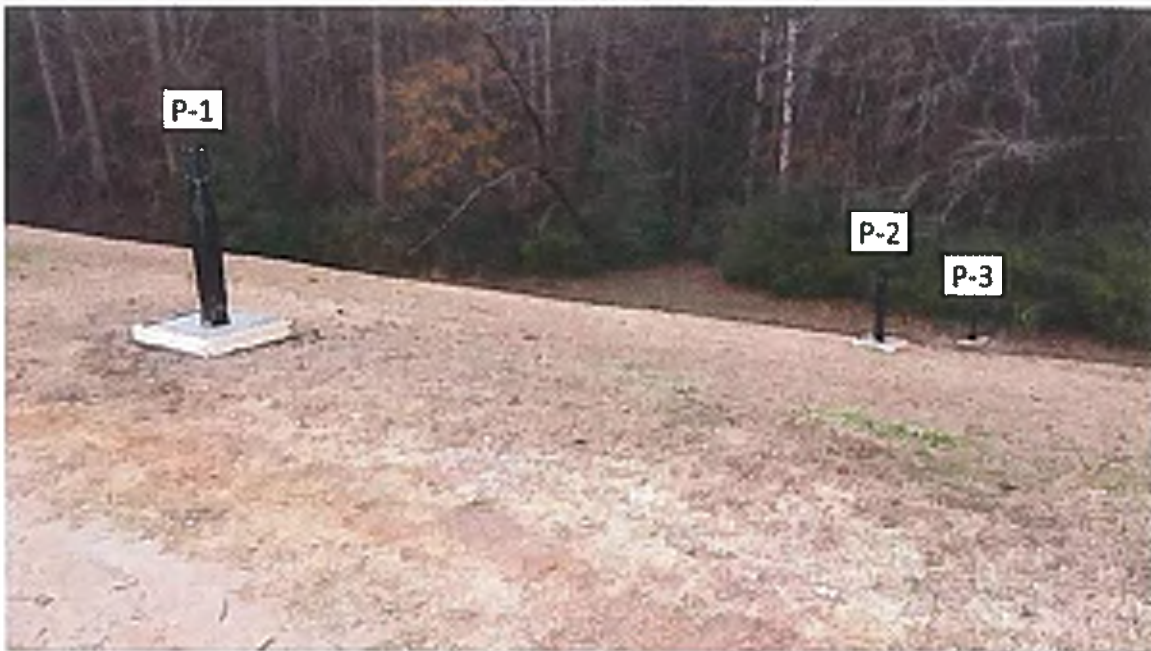
Piezometers P-1 through P-3; photographed on 12/6/2013

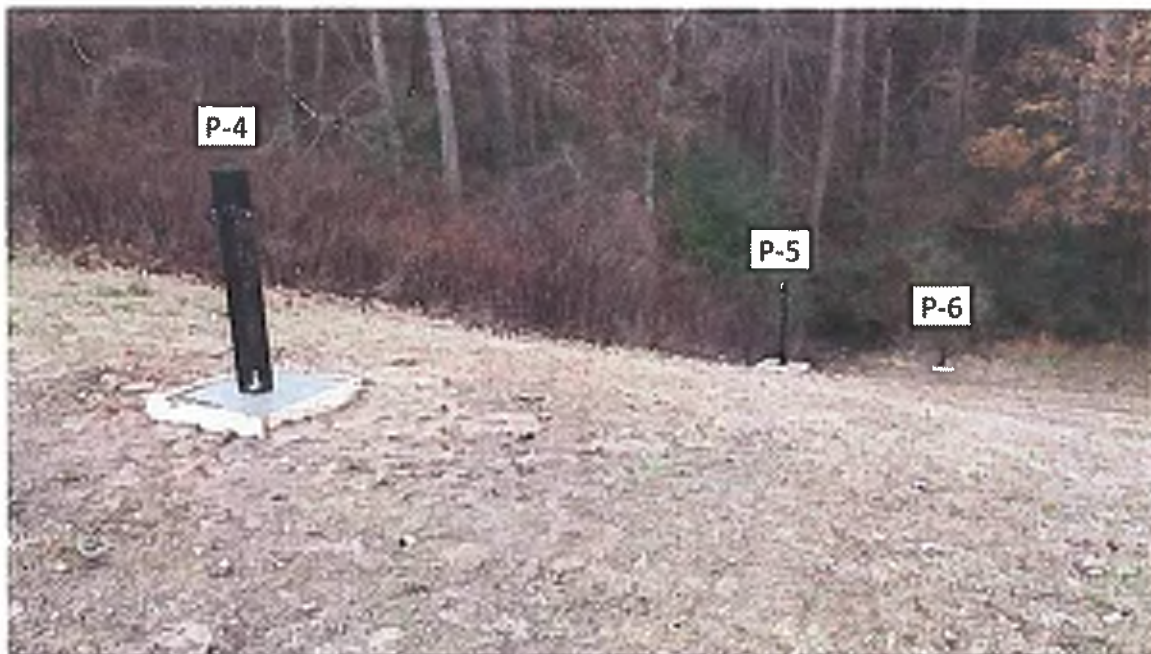
Piezometers P-4 through P-6; photographed on 12/6/2013

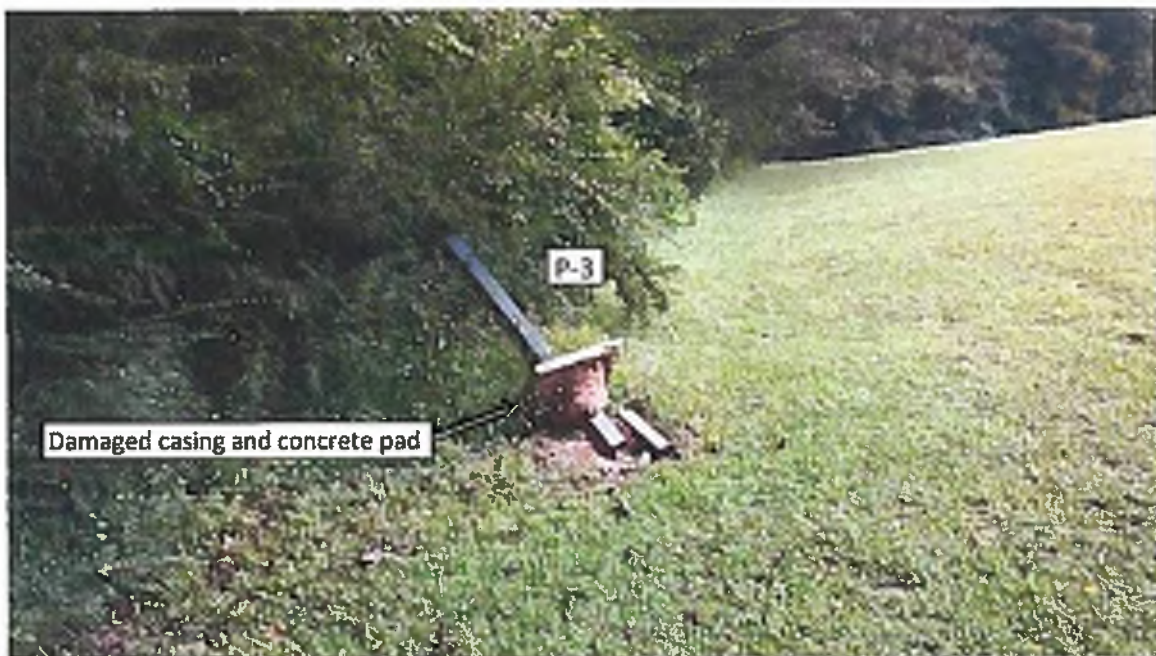
Damaged Piezometer P-3; Facing East; 09/08/2014

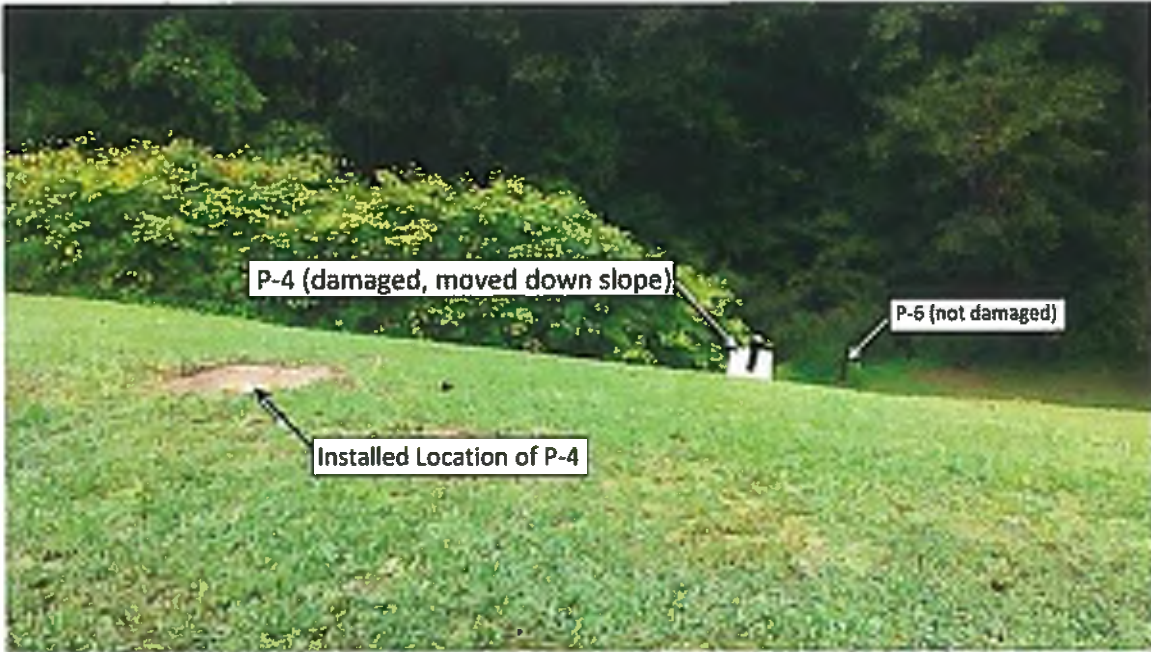
Piezometers P-4 through P-6; Facing Northwest; 09/08/2014

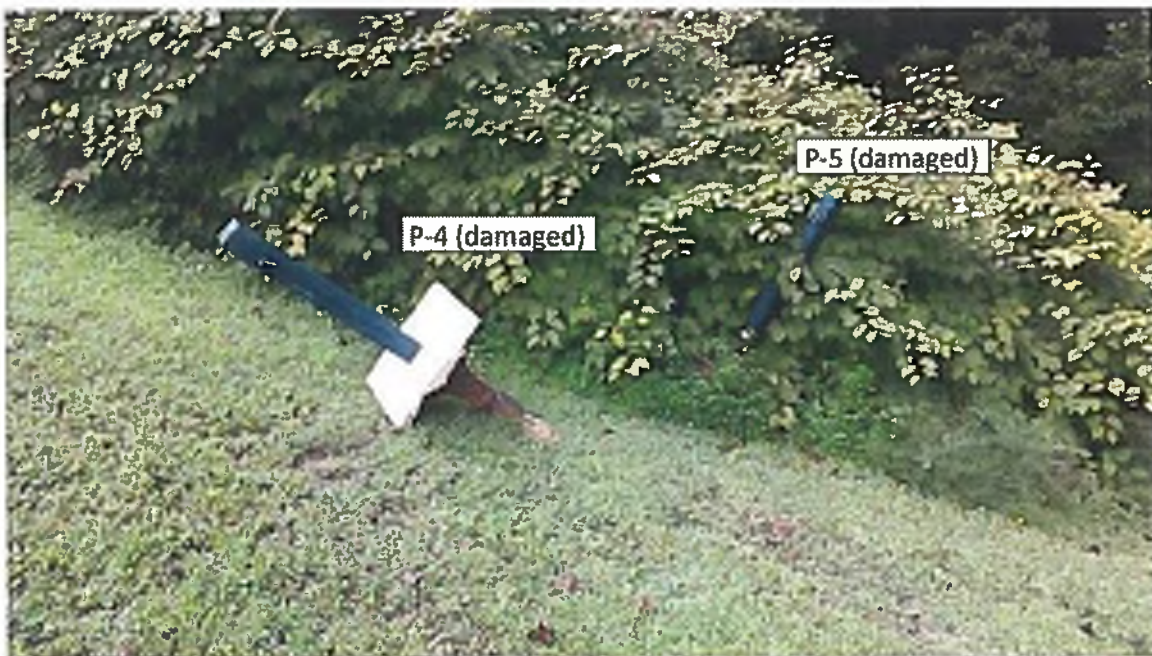
Damaged Piezometers P-4 and P-5; Facing West; 09/08/2014

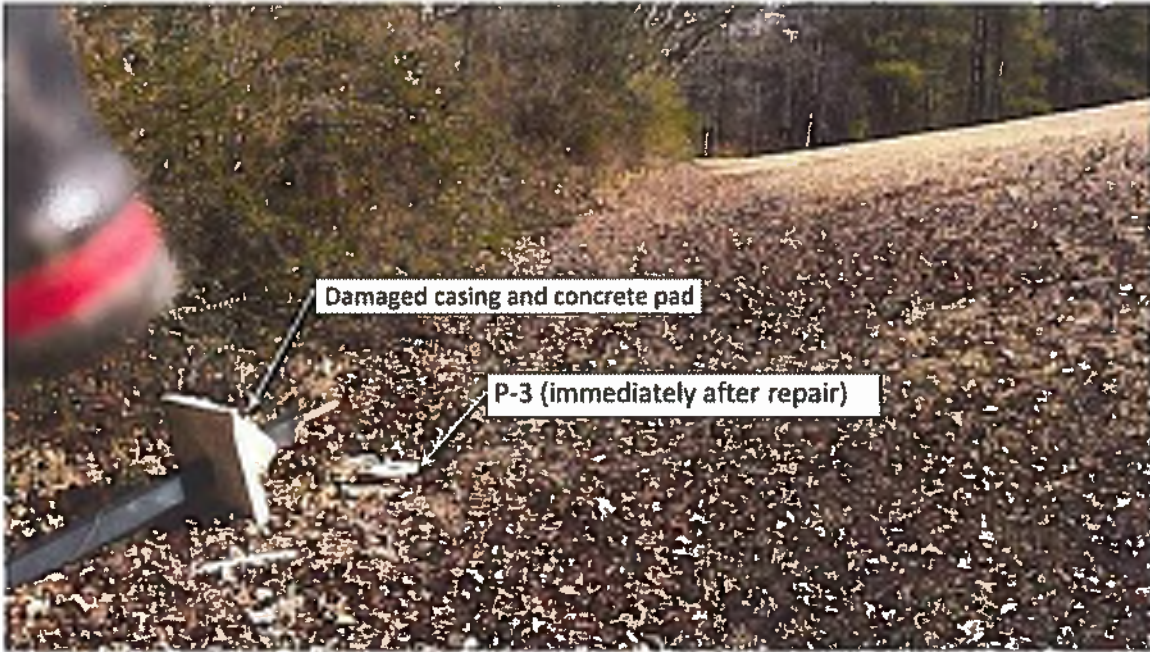
Repaired Piezometer P-3; Facing East; 01/27/2015

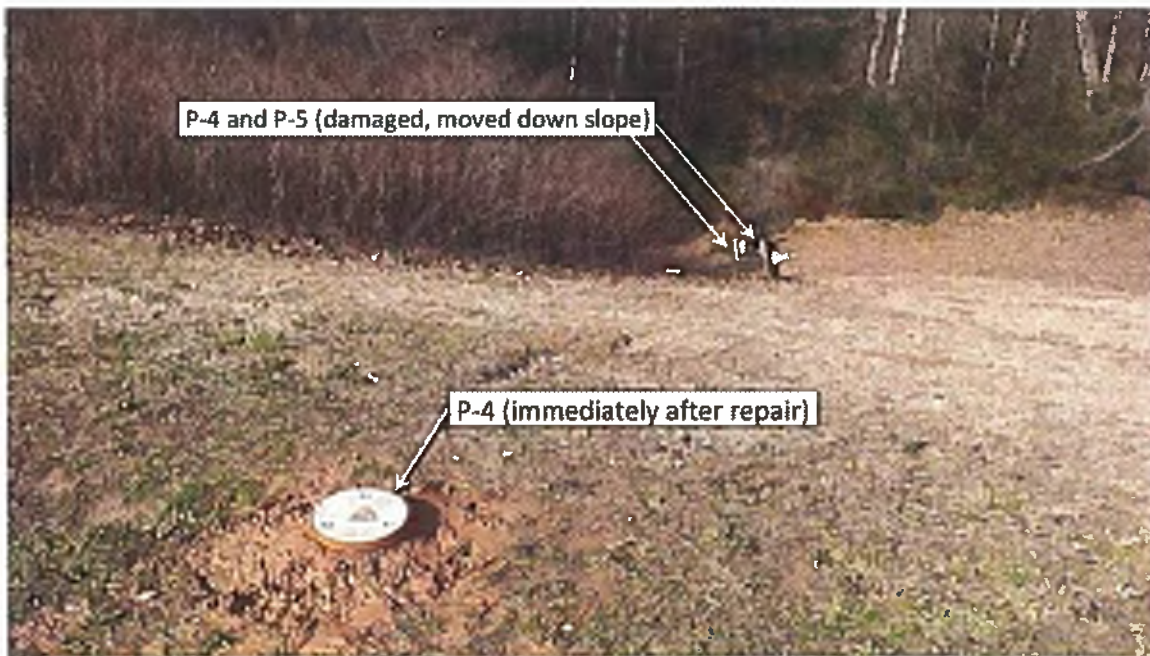
Repaired Piezometer P-4; Facing Northwest; 01/27/2015

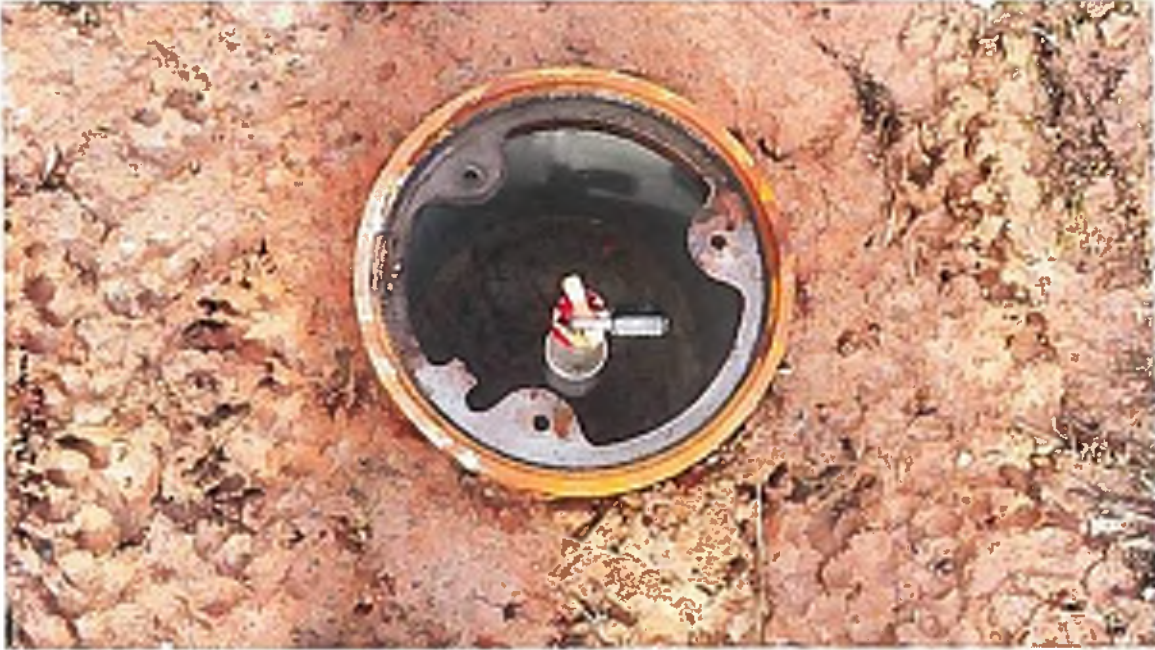
Repaired Piezometer P-4 with Protective Cover Removed; 01/27/2015

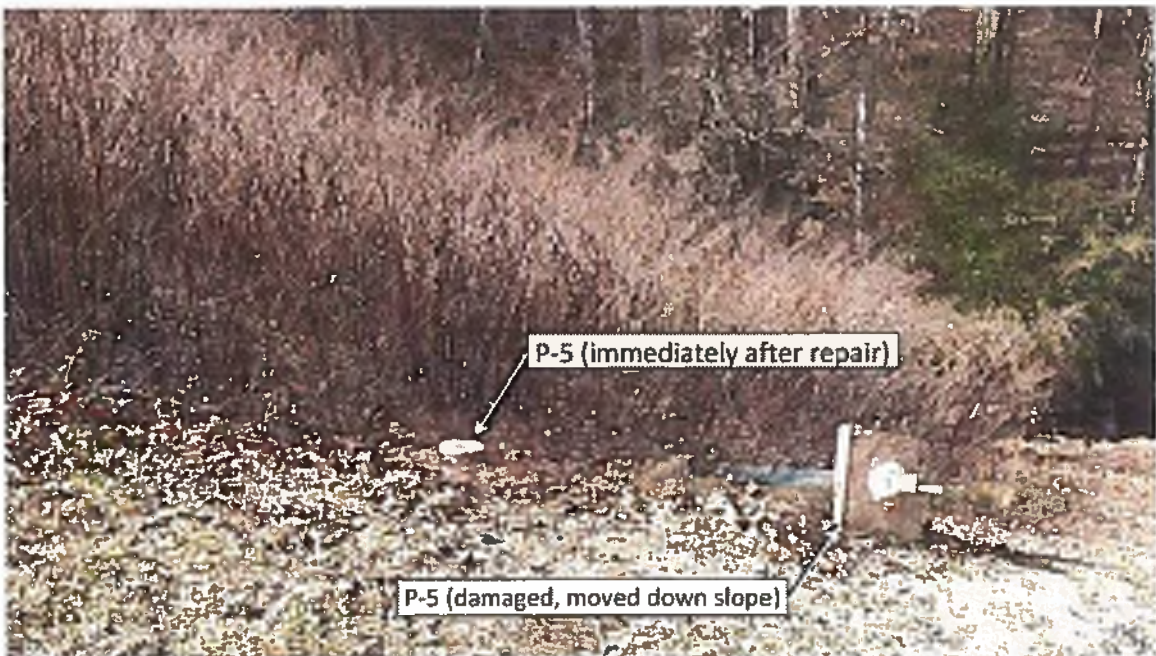
Repaired Piezometer P-5; Facing West; 01/27/2015

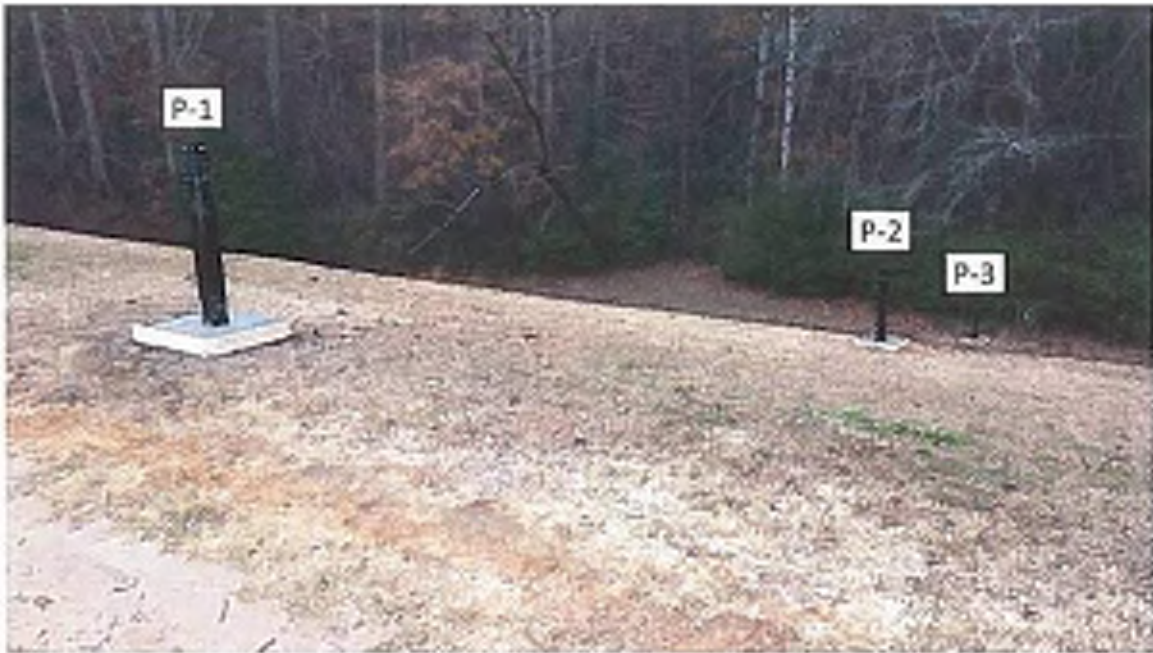
Piezometers P-1 through P-3; photographed on 12/6/2013

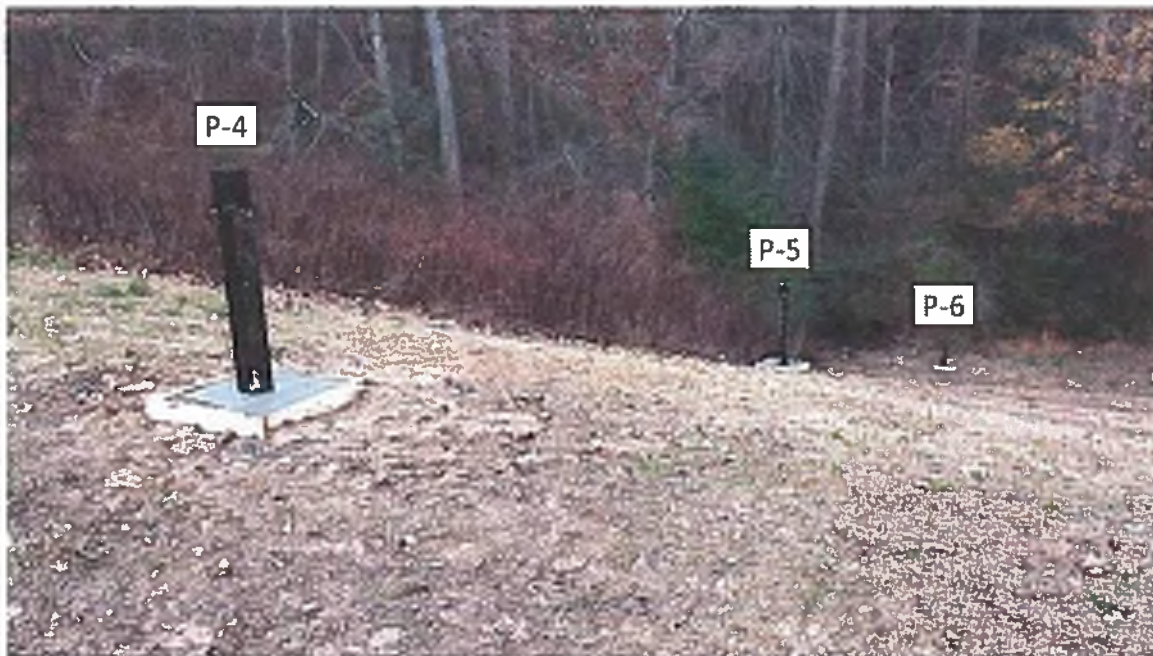
Piezometers P-4 through P-6; photographed on 12/6/2013

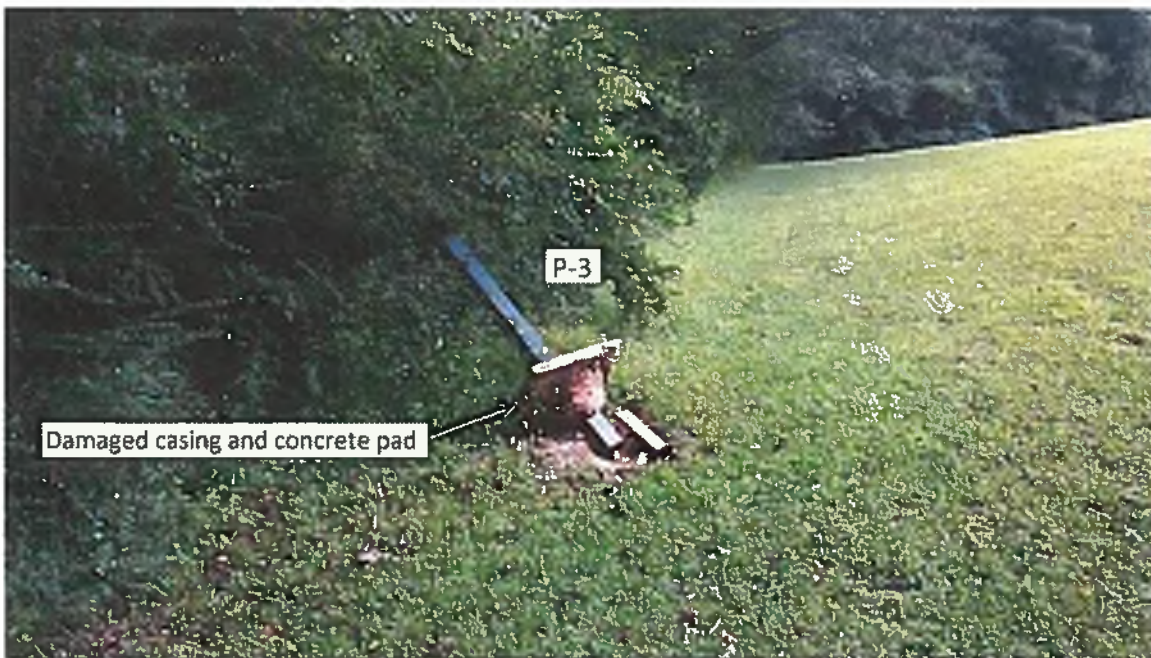
Damaged Piezometer P-3; Facing East; 09/08/2014

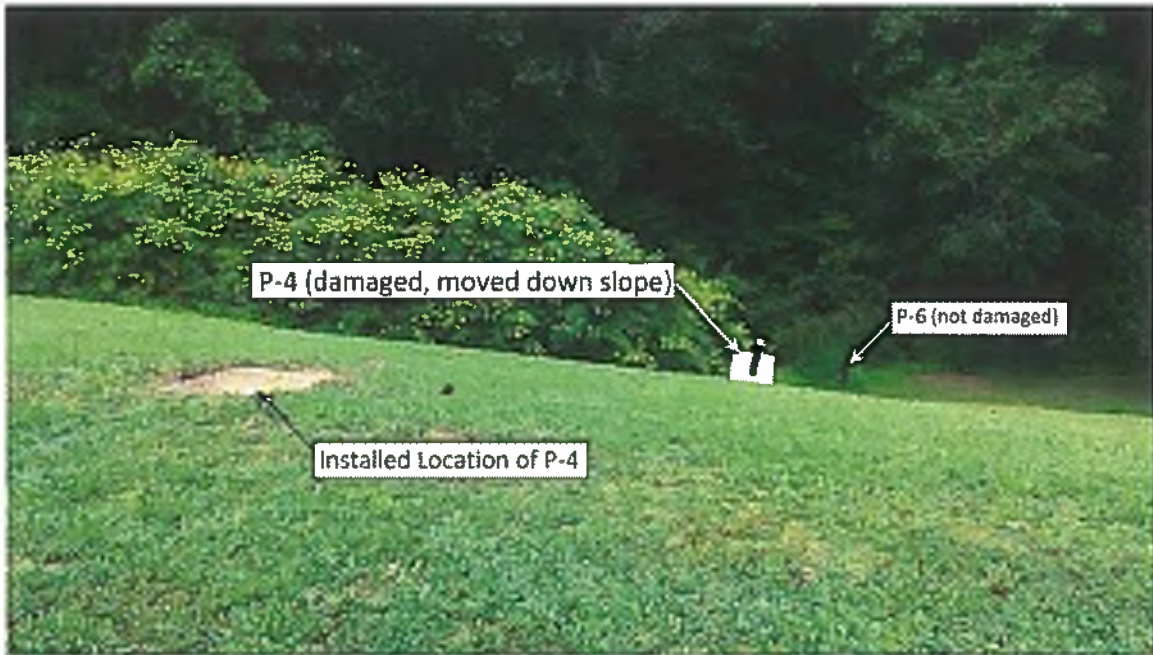
Piezometers P-4 through P-6; Facing Northwest; 09/08/2014

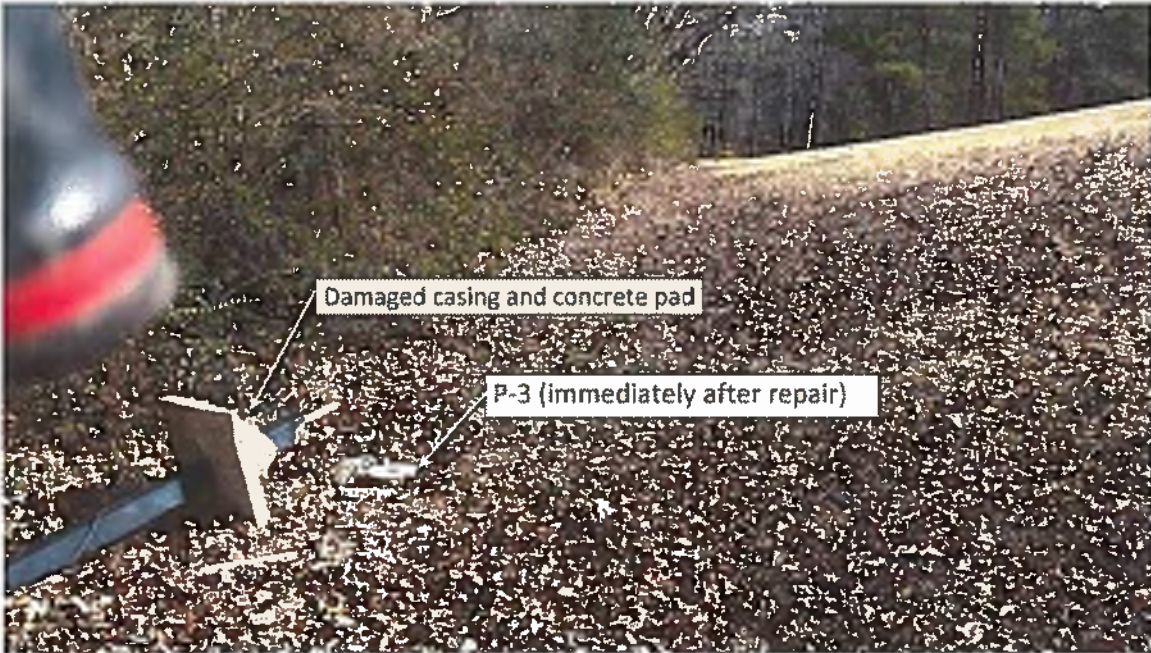
Repaired Piezometer P-3; Facing East; 01/27/2015

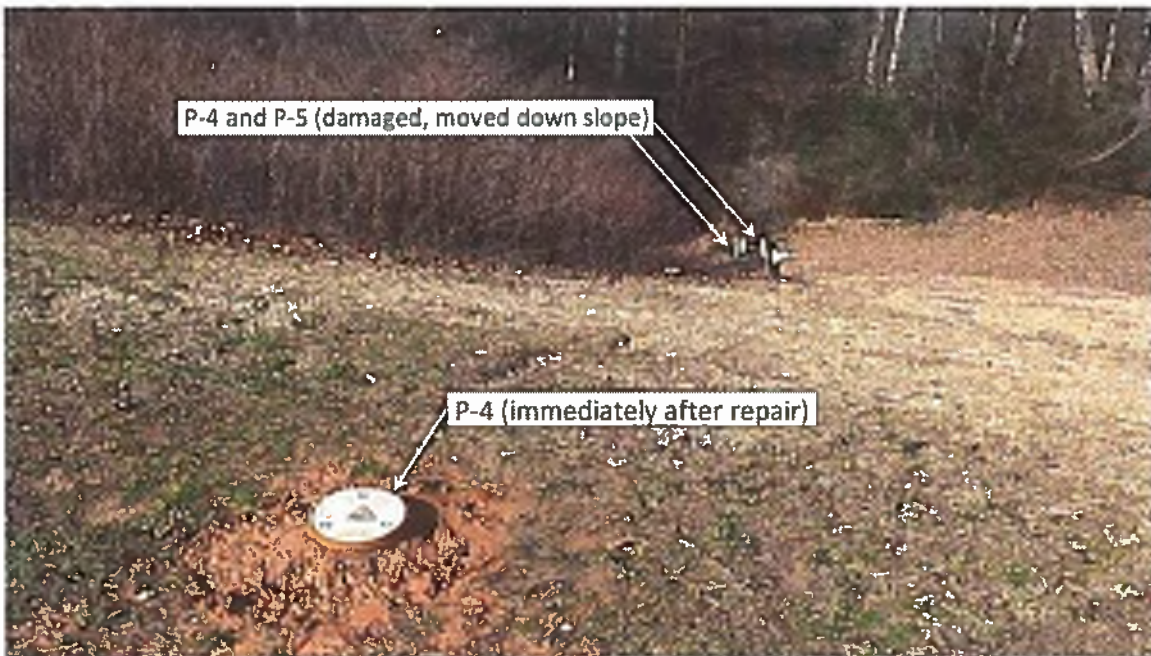
Repaired Piezometer P-4; Facing Northwest; 01/27/2015

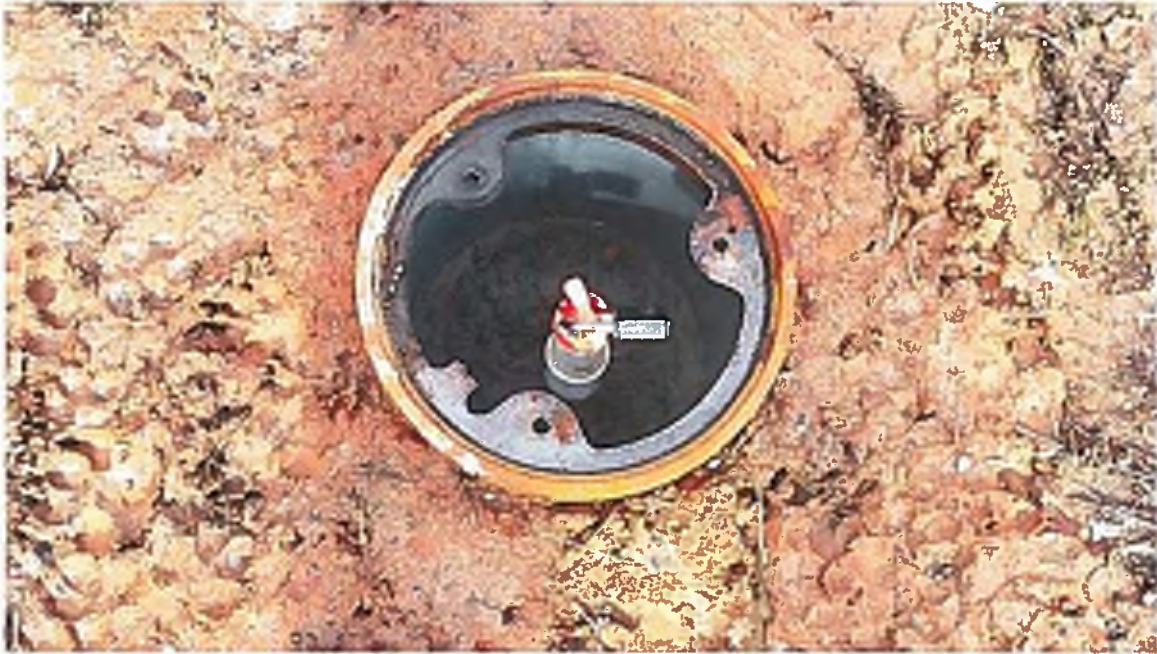
Repaired Piezometer P-4 with Protective Cover Removed; 01/27/2015

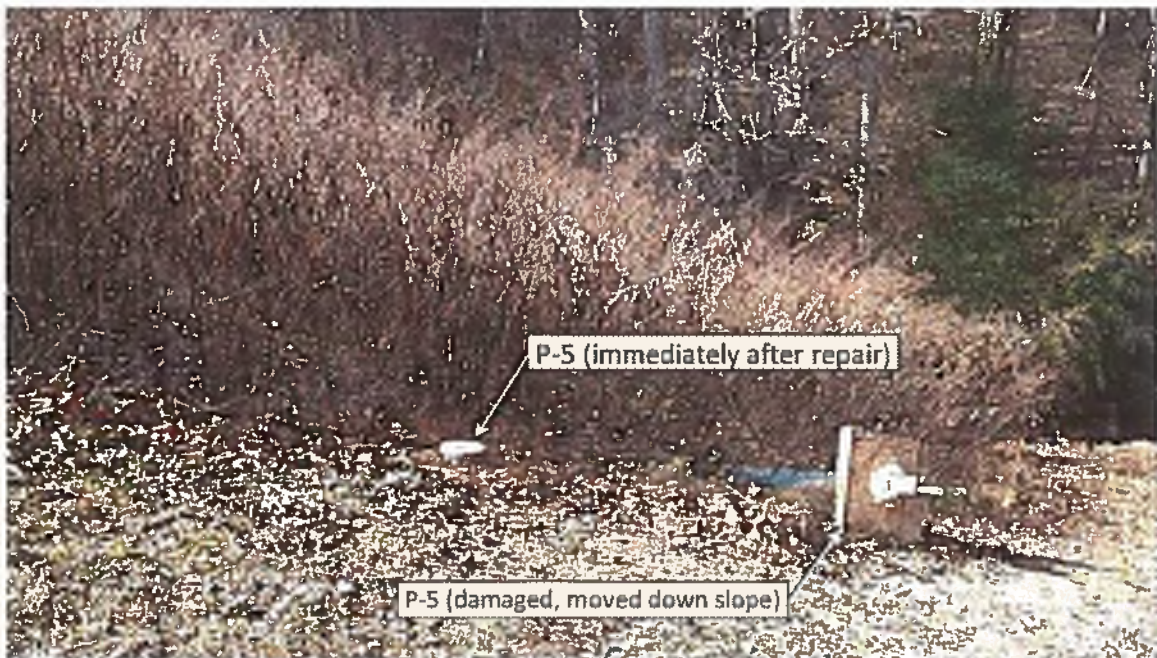
Repaired Piezometer P-5; Facing West; 01/27/2015

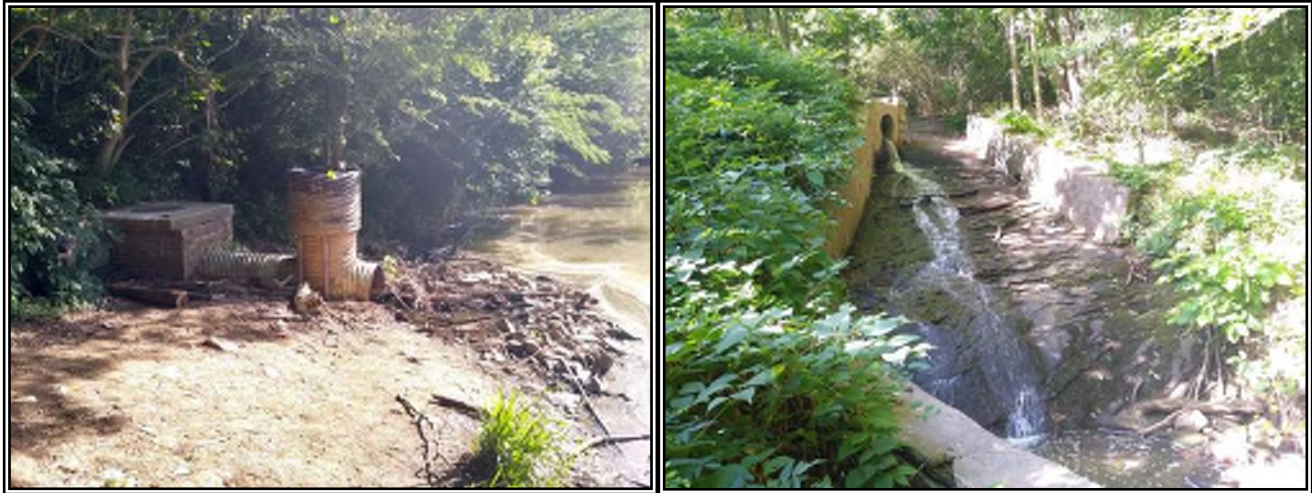
Spillway Locations

Based on information provided by the client and our review of a survey plan performed by Accura, we understand that the principal spillway is an approximately 12-foot-wide natural rock spillway located at the northwestern end of the dam. The outlet control system is a 30" corrugated metal pipe at the end of

the left abutment that connects to a junction box. The drain outlet for the lake consists of a 30-inch diameter reinforced concrete pipe running through the west side of the dam near the left abutment and outflows onto the old stone spillway.

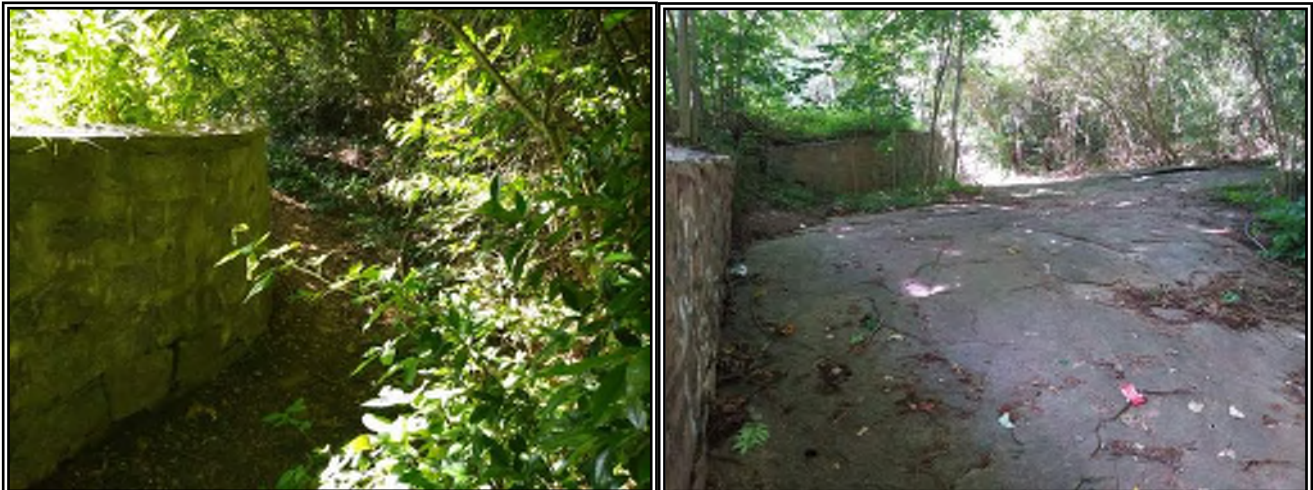
An emergency spillway system was observed for this dam. It consisted of the old spillway system on the northwest corner of the dam. In the event of high water, a low point on the corner of the left abutment would allow water to flow out onto a rock spillway abutted by mortared rock walls.

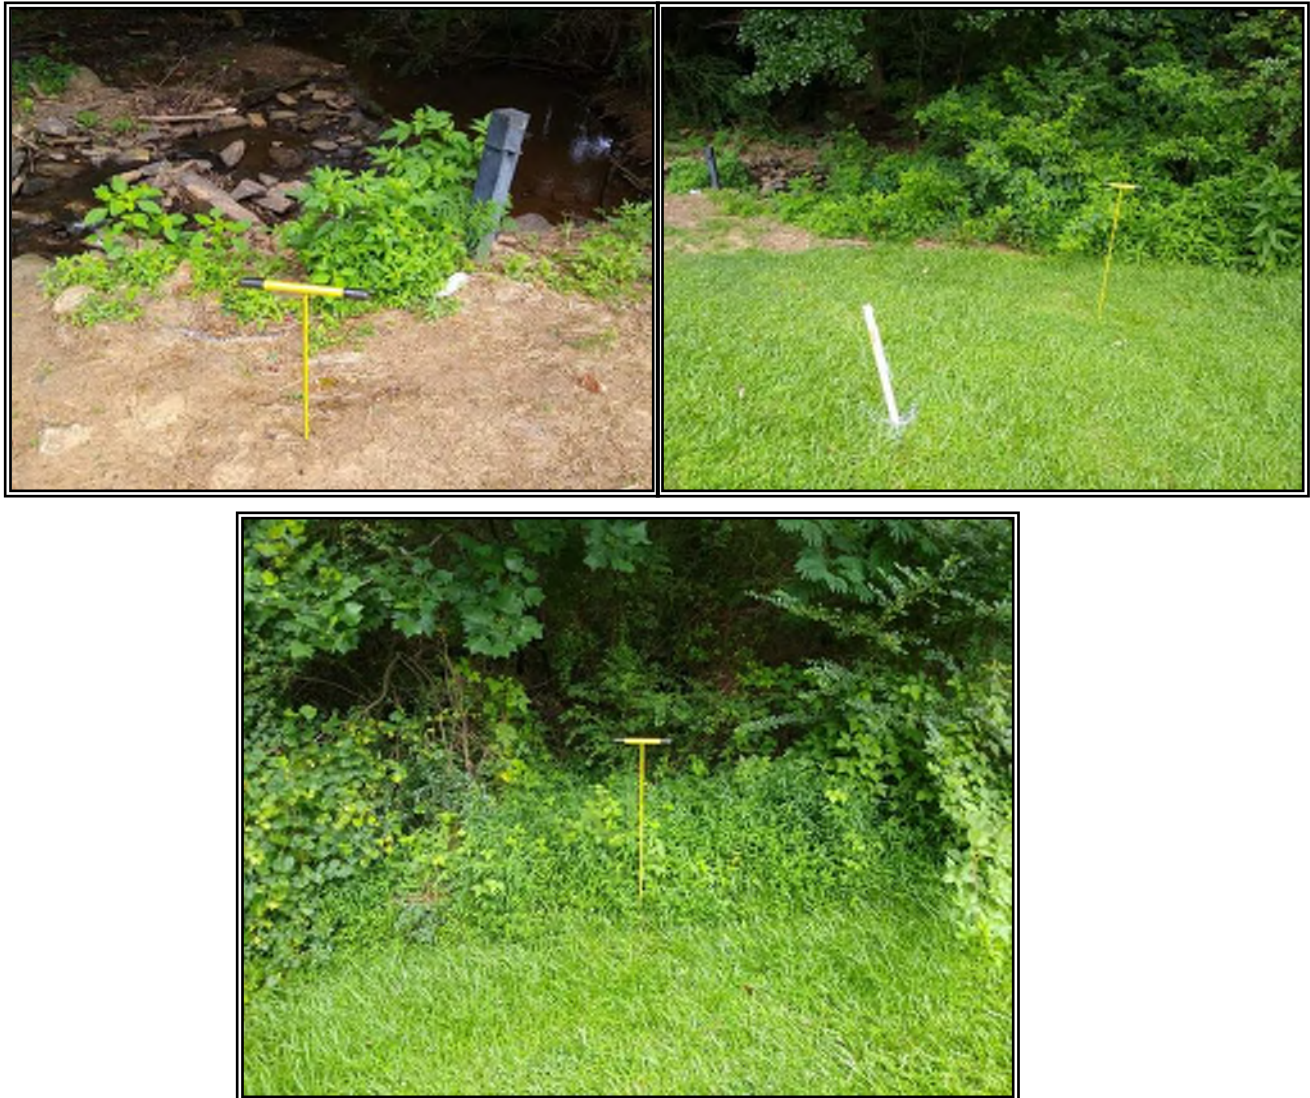
Probe Rod

The accessible areas along the downstream toe of the dam were visually observed and probed with a probe rod. The probed areas along the downstream toe were generally firm, and there were no obvious visual indications of seepage. The probed area along the creek bank near the piezometer, P-6, was found to be loose in consistency. We note that some large trees and dense vegetation were present along the lower portion of the downstream face and toe of the dam.

The bottom 2 inches of the downstream face and toe of the dam were noted to be firm when probed with the probe rod. No trees along the downstream face were noted to be leaning, which is often an indication of long-term slope movement.

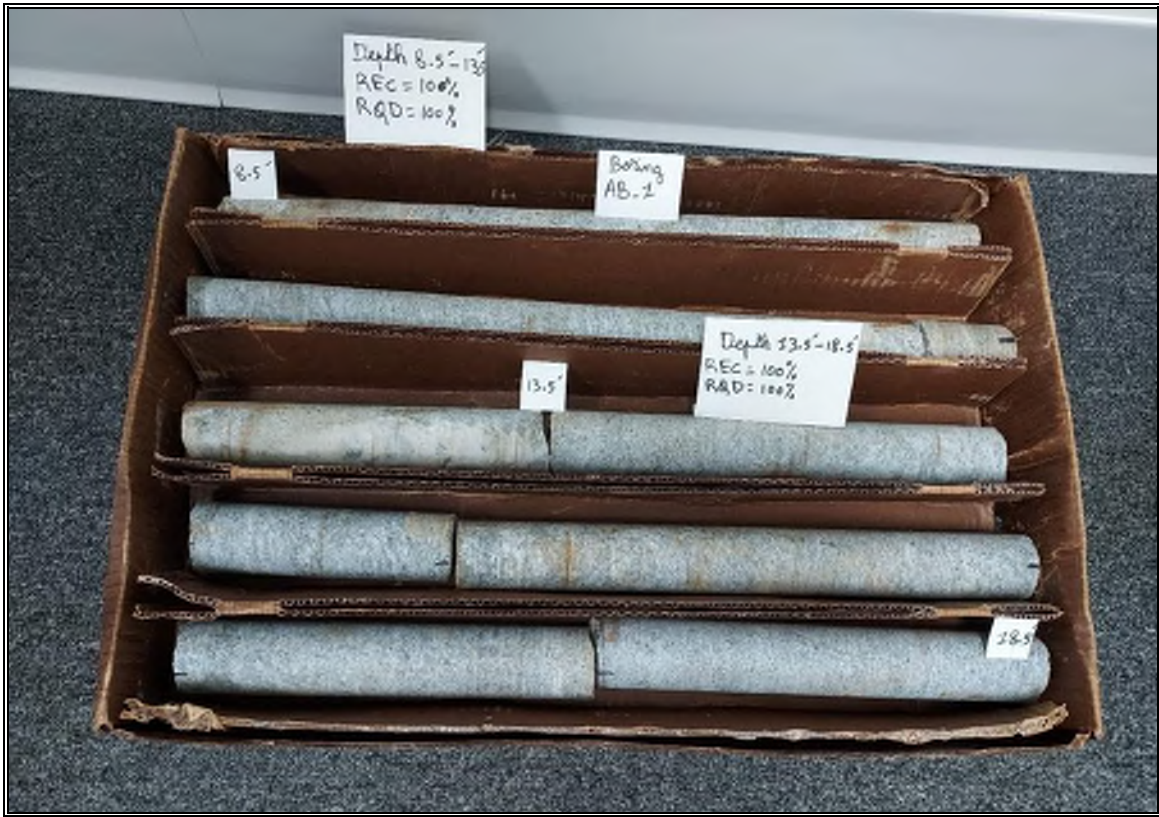
Rock Core from Boring AB-1 (1st Run @ 8.5'-13.5', 2nd Run @ 13.5'-18.5')

The borings were backfilled with the cement-bentonite grout upon completion of drilling for safety considerations. For a more precise description of the conditions encountered within the borings, please refer to the Boring Logs provided in The Appendix II.

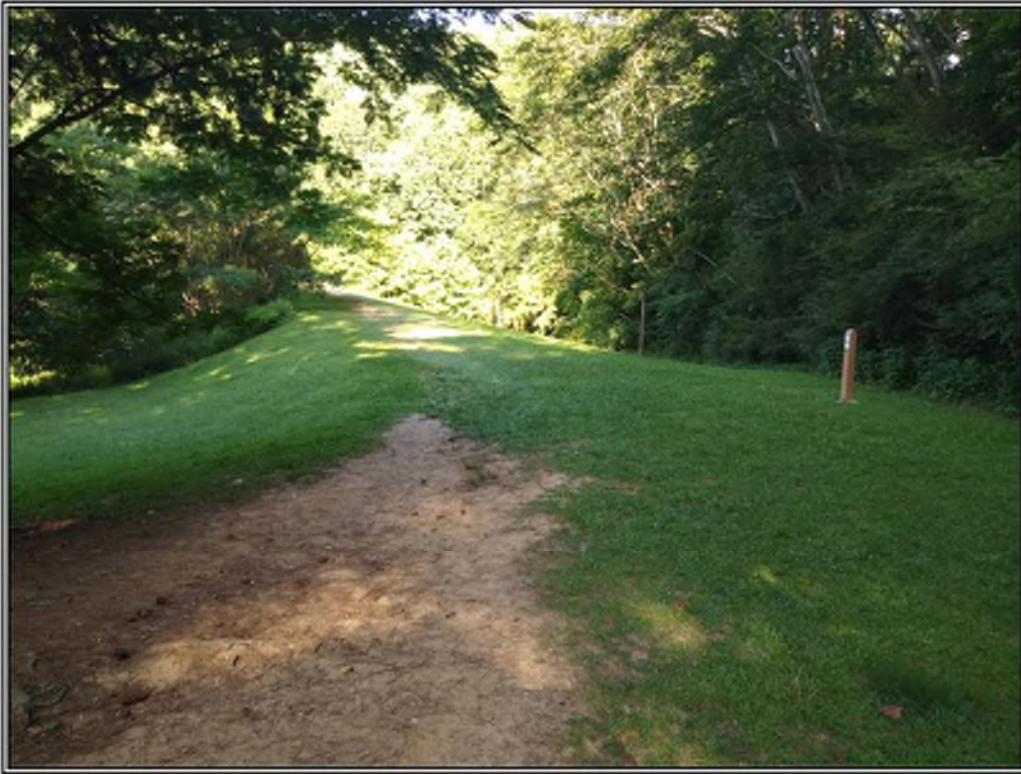
From east to west showing the crest of the Dam.

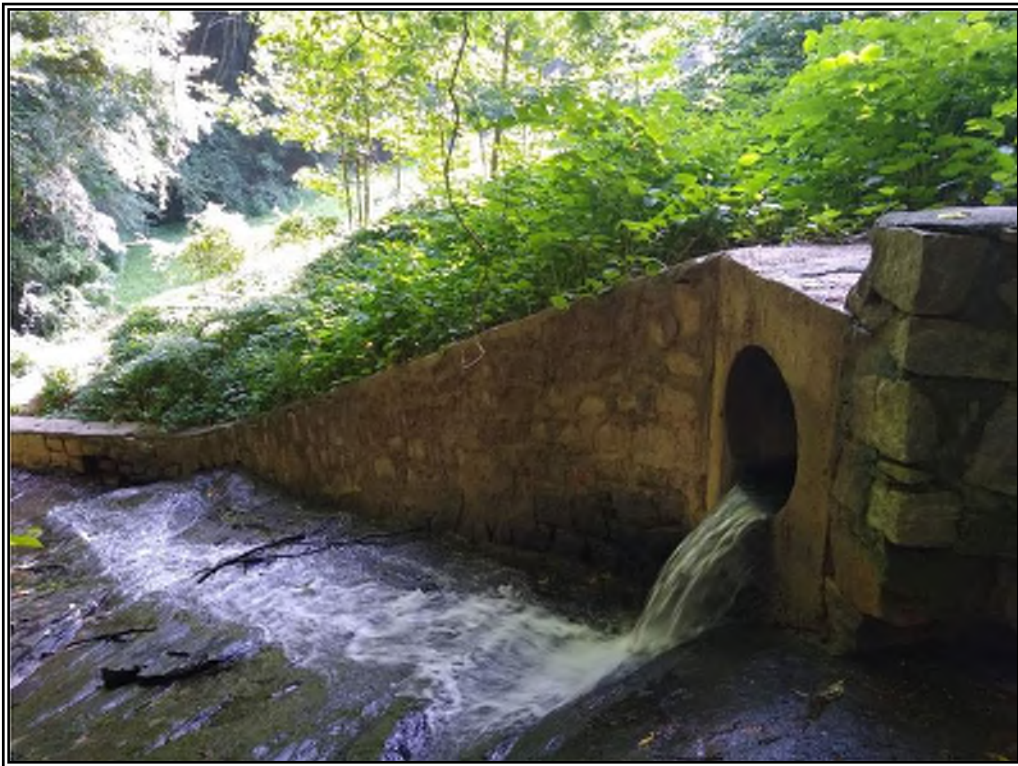
Concrete outlet located at the northern end of the left abutment.
