Lake Erin Dam Rehabilitation

Basis of Design Report
NID ID: GA01324

City of Tucker
DeKalb County, Georgia

September 13, 2024

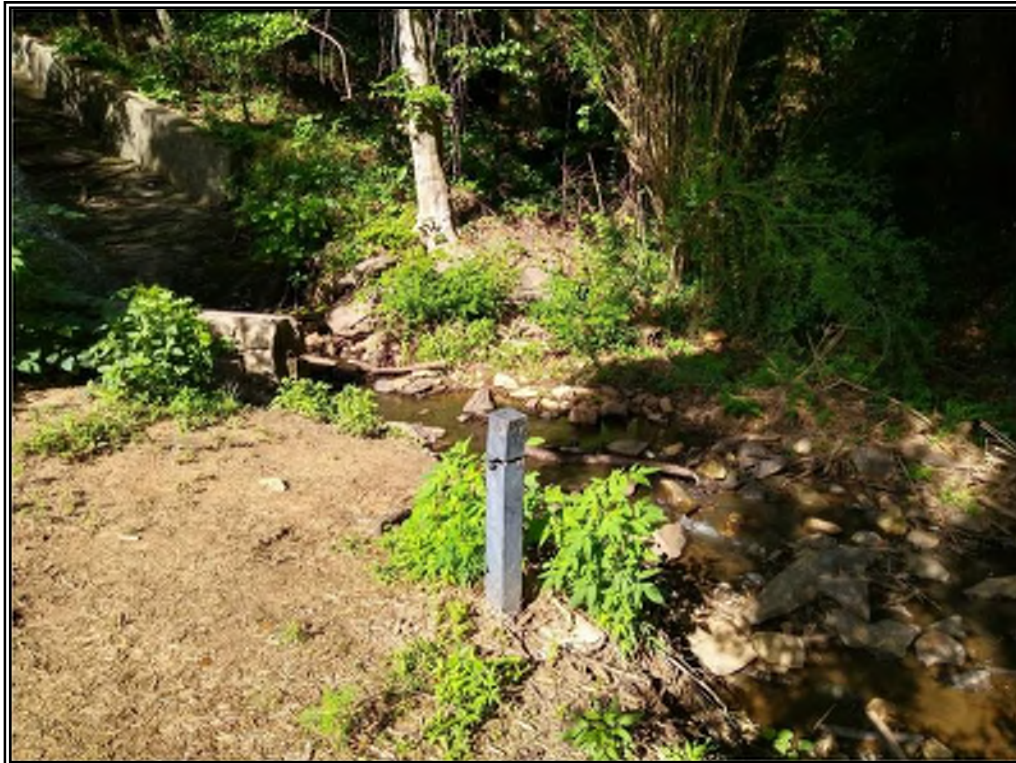
Downstream toe of the dam.

The bottom 2 inches of the downstream face and toe of the dam were noted to be firm when probed with the probe rod. No trees along the downstream face were noted to be leaning, which is often an indication of long-term slope movement.

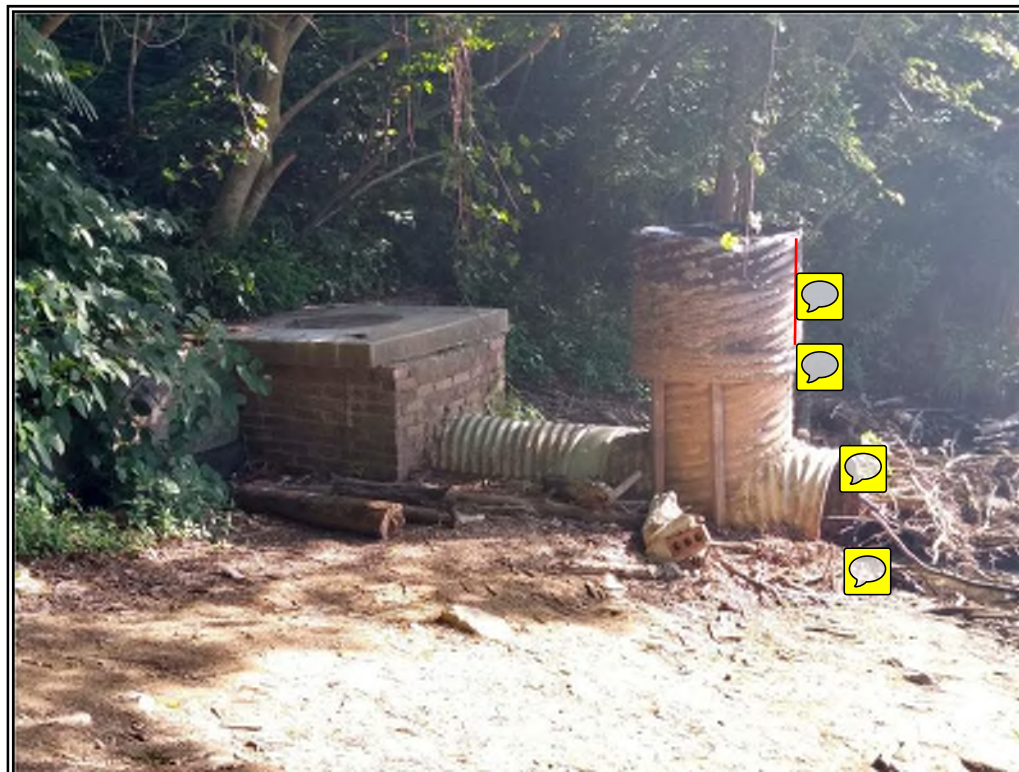
Spillway system located at the southwest end of the dam.

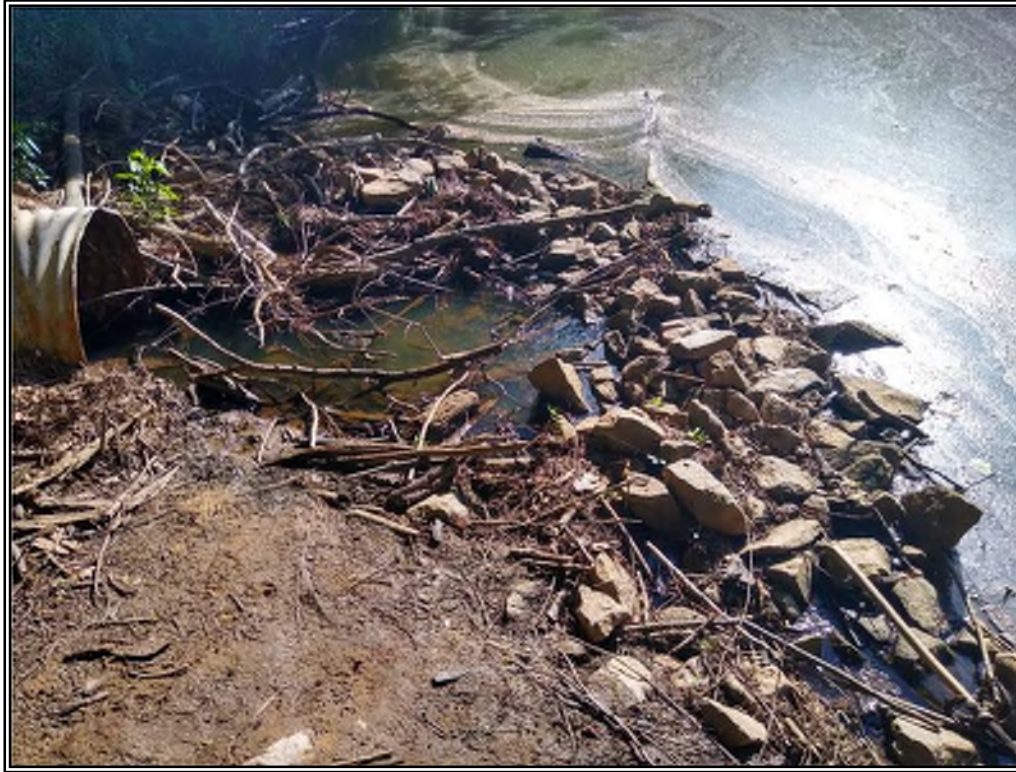
Outlet of the principal spillway constituted of riprap rocks.

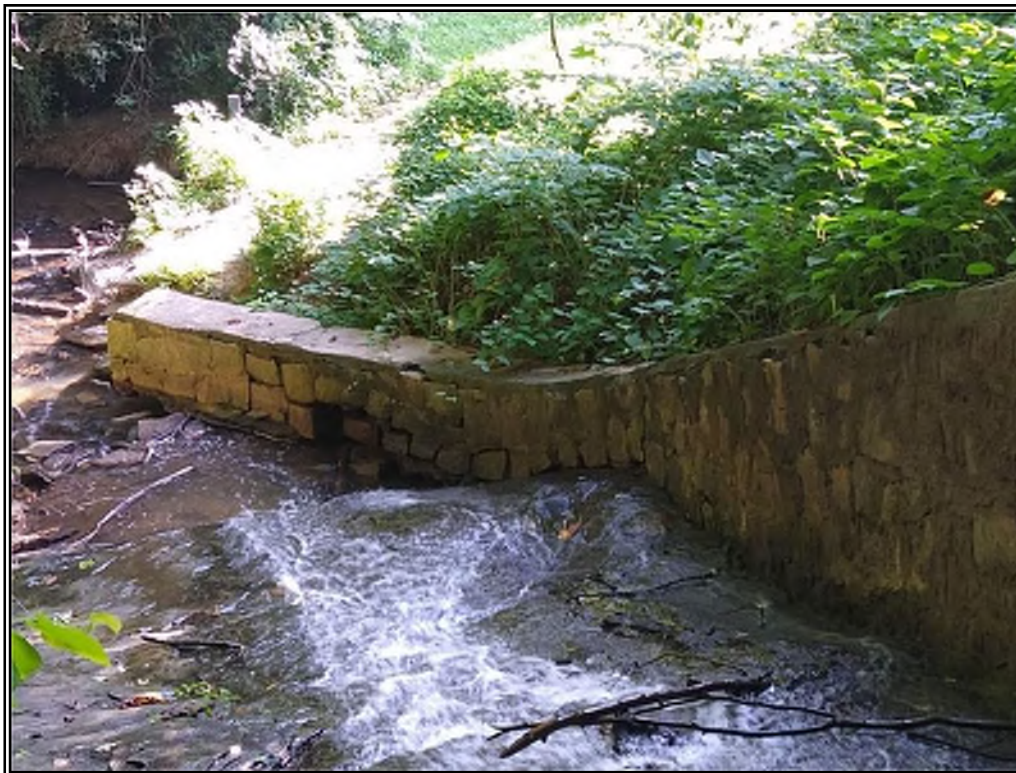
Old spillway located by the downstream face of the Dam.

An emergency spillway system was observed for this dam. It consisted of the old spillway system on the northwest corner of the dam. In the event of high water, a low point on the corner of the left abutment would allow water to flow out onto a rock spillway abutted by mortared rock walls.

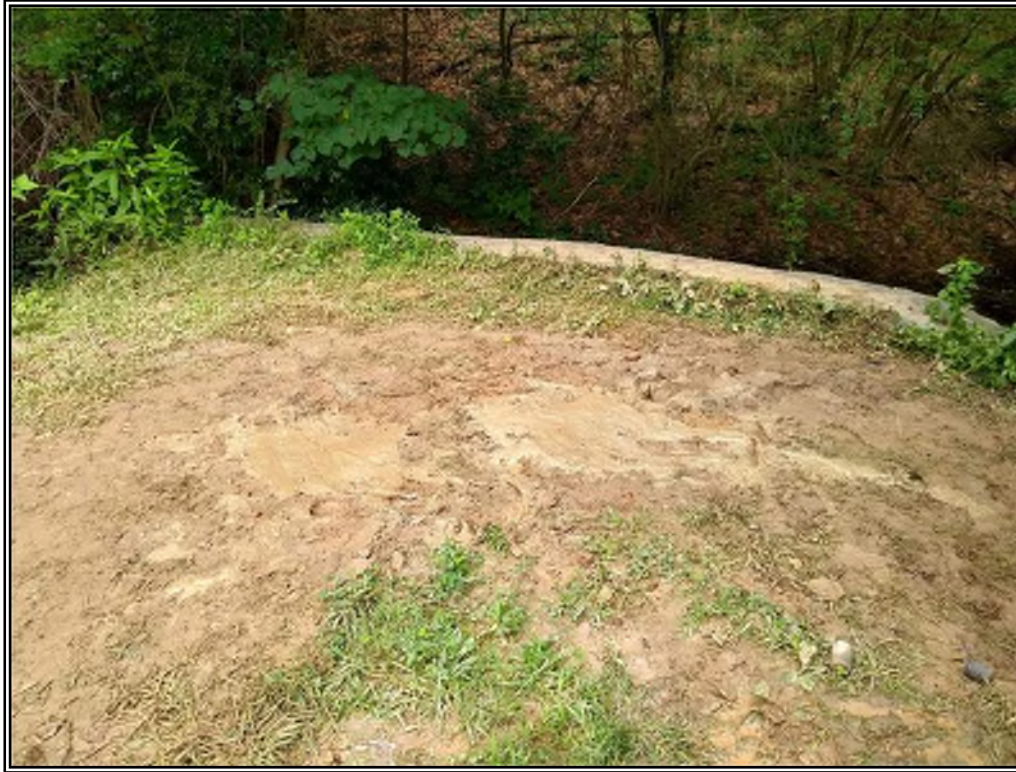
Showing boring AB-1 at the downstream area of the dam.

Existing Fill: Below a thin 2-inch layer of topsoil, boring AB-1 encountered fill soils to a depth of approximately 6 feet below the existing grade. The fill soils encountered in boring generally consisted of loose to medium dense silty sand (SM), and Standard Penetration Test (SPT) resistances (N-values) ranging from 5 to 14 bpf.

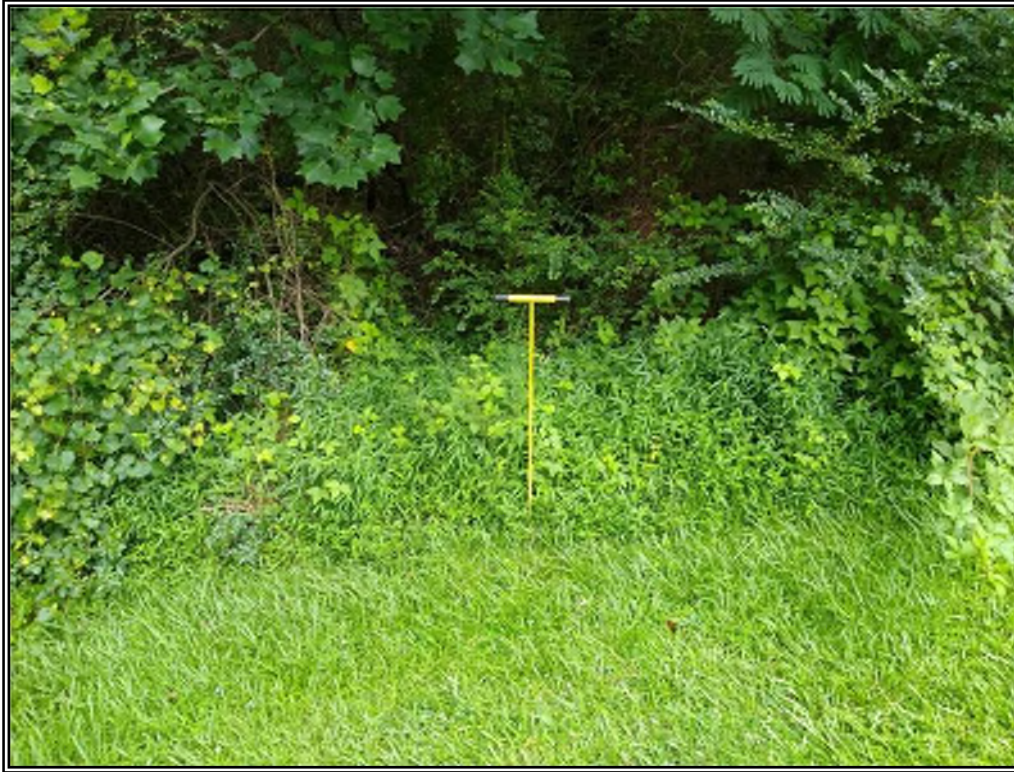
Probe test done on the north area of the dam.
